## D7.4b - Renovated Case Studies, Madrid

**Deliverable Title:** D7.4b – Renovated Case Studies, Madrid

The building selected by EMVS as a demonstration of project iNSPiRe practices is located at 47, Canción del Olvido street, Ciudad De Los Angeles in Madrid.

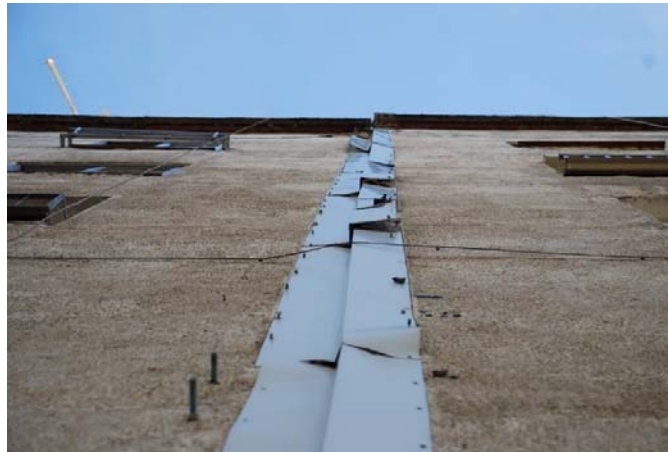
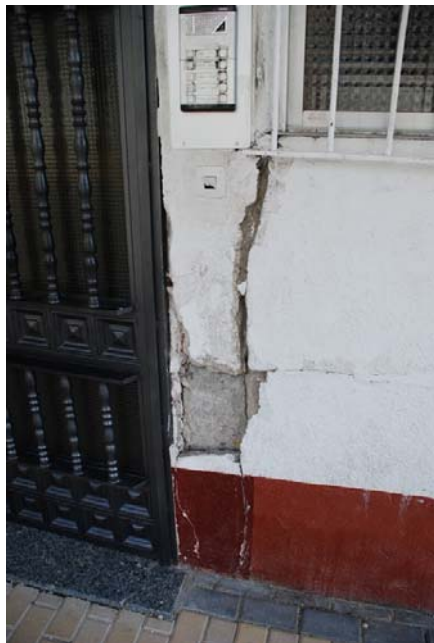
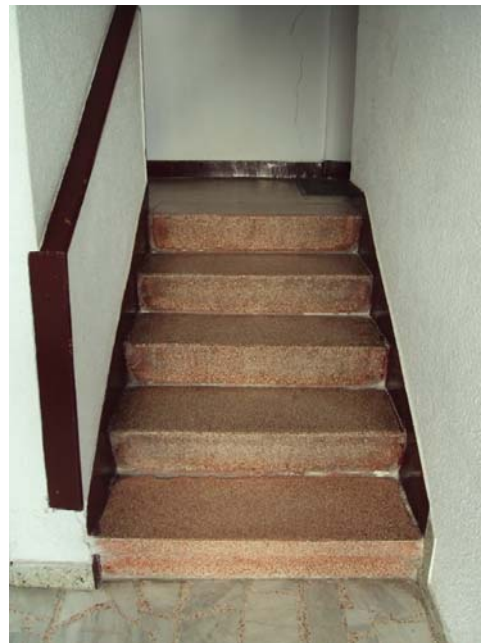
The condition of this property prior to the renovation jobs showed a number of defects, in particular foundation problems derived from the structure's differential settlement, which caused significant cracks on the building facade. Besides, the building envelope lacked any kind of insulation and the roof's insulation and waterproofing consisted of what is known as '*Catalonian roofing*', traditional Spanish construction technique consisting of an aired/ventilated chamber providing both insulation and waterproofing.

Figure 3 – Cracks assessed during audits

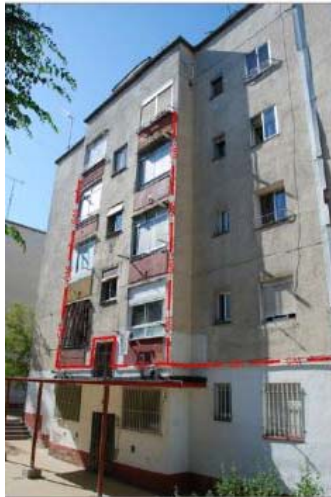
The gas piping distribution as well as the phone lines and electricity wiring are located along the façade.

Figure 6 - Gas piping

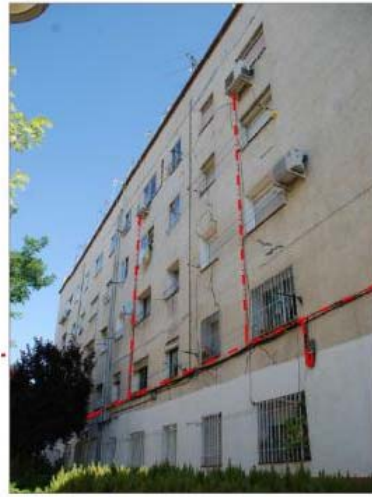
Figure 7 - Telephone lines

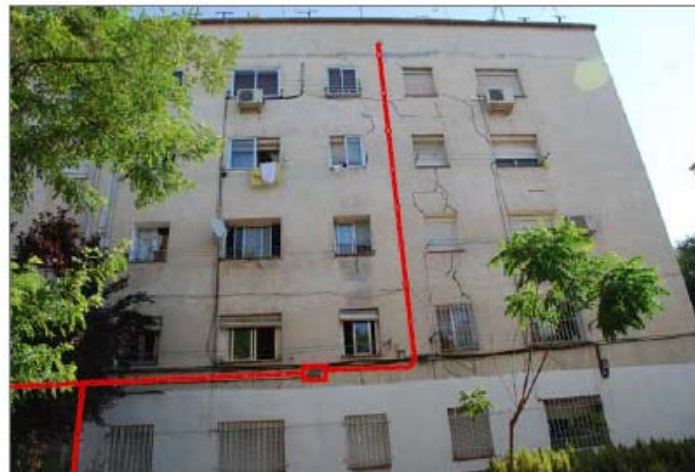
Figure 8 - Electricity wiring

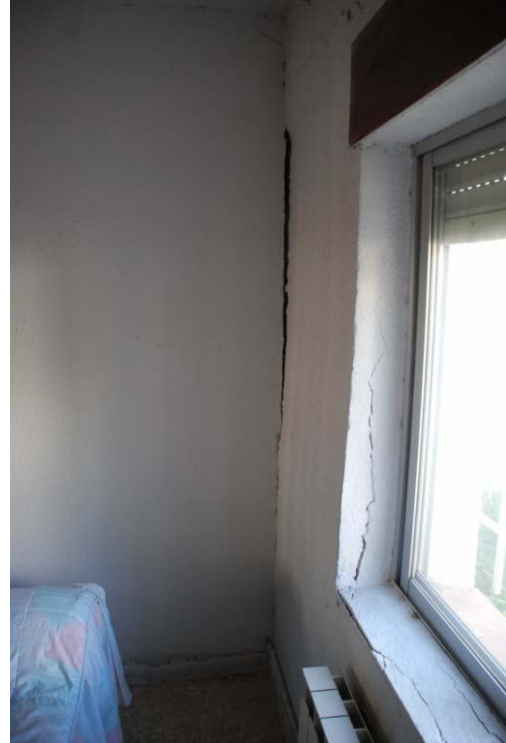
As already mentioned the general condition of this building was poor and deteriorated, showing significant cracks on structure and envelope, damaged fittings, fixtures and joinery, construction flaws as well as unfinished renovation works which did not improve the building condition.

Figure 18 – Cracks inside sleeping room

The renovation process went through a number of actions, starting from the structural reinforcement of the building, the thermal insulation of the envelope and the installation of a centralised heating and cooling system.

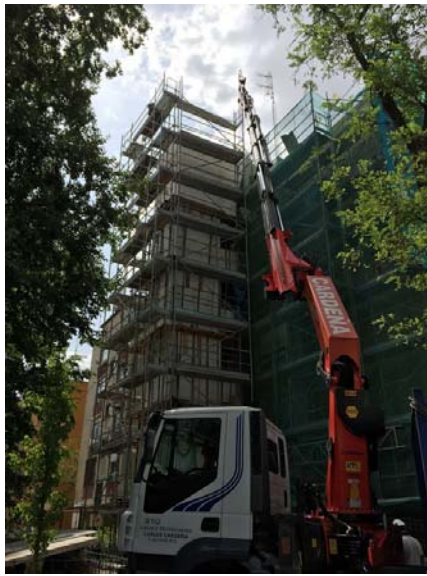
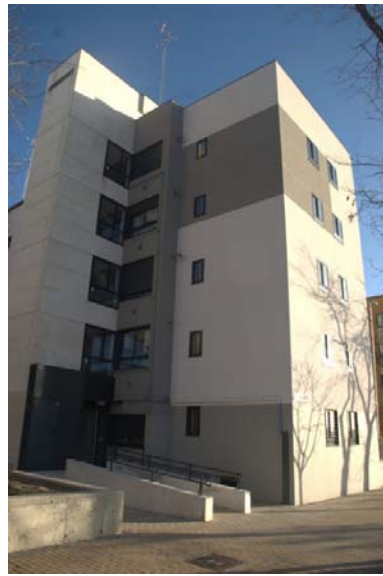
Figure 19 – Lift shaft during installation and at the end of the retrofit

5. In order to build the new lift shaft, the existing stairwell had to be demolished and a new one put in place. It is worth to keep in mind that during all this process the building was inhabited by owner-occupiers.
6. Construction of a new roof structure by means of a metallic ring structure braced with steel stringers and connected to the new lift shaft structure. The former has been finally replaced by a permanent concrete slab attached to structural walls.
7. Repair facade cracks, eliminate external artefacts (aerials, satellite dishes, etc...) and consolidate boiler exhausts and vents in order to increase the aesthetical value of the property.

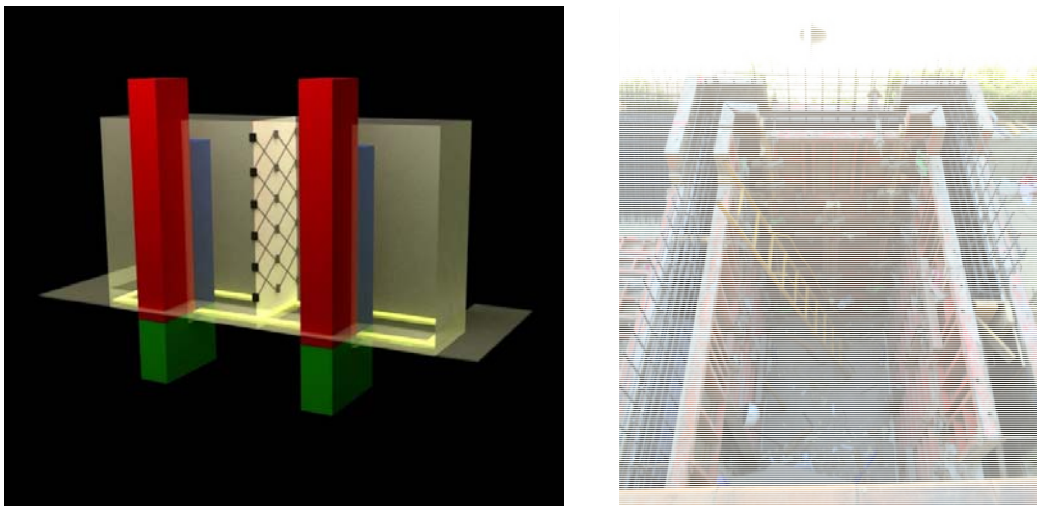
Figure 20 – 3D preliminary analysis (left) and lift shaft foundation (right)

The new lift shaft - manufactured with three concrete walls and beams that join it to the concrete façade of the building - is based on six new piles.

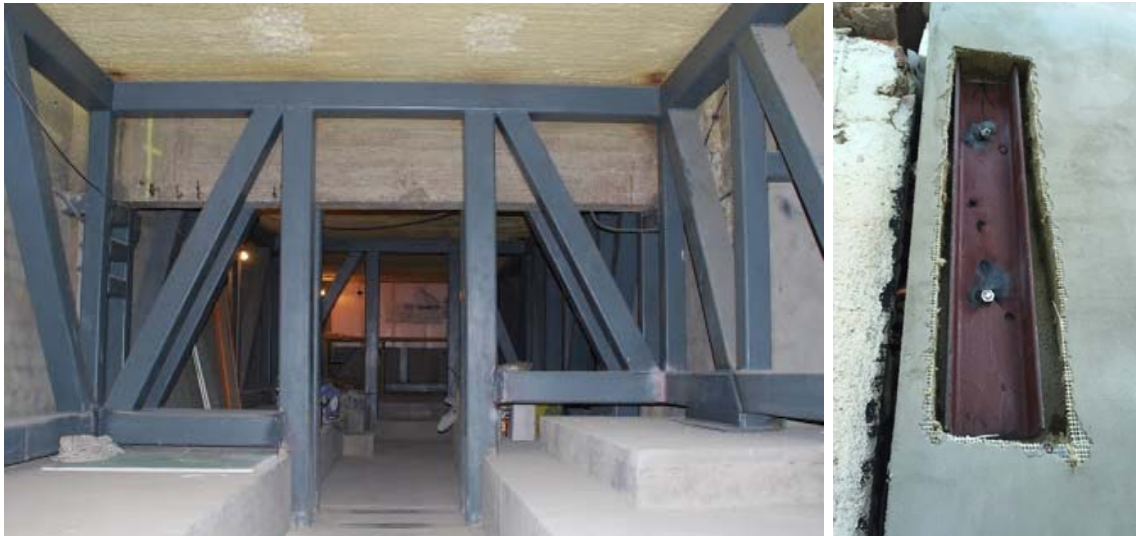
It has been mentioned already that the building was in a bad status of conservation before retrofit start: the building had a conventional foundation, which was partially micropiled in 2003 to try a first structural recovery. Despite this, depth and status of the existing base were not known.

Figure 21 – Steel structure in the foundation reinforcing the existing bearing piles (left) and anchor plates (right)

Thirteen grade slabs, installed in front and partially below the existing stairway, constitute the new foundation that distributes evenly the vertical and lateral loads of the building on the ground (green in Figure 20). To this purpose, a steel structure is interposed between grade slabs and the ground floor of the building.

The horizontal structure of the building is made of concrete beams and slabs. The existing structure has a thickness of 22 cm including the pavement. The horizontal structure was not altered except in the stairwell and the connection with the new lift shaft. The existing stairway was completely substituted with a new metal one. This is welded to anchor plates screwed onto the concrete slabs of each floor.

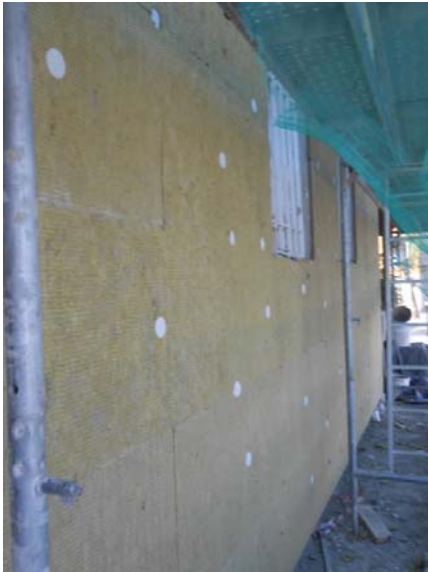
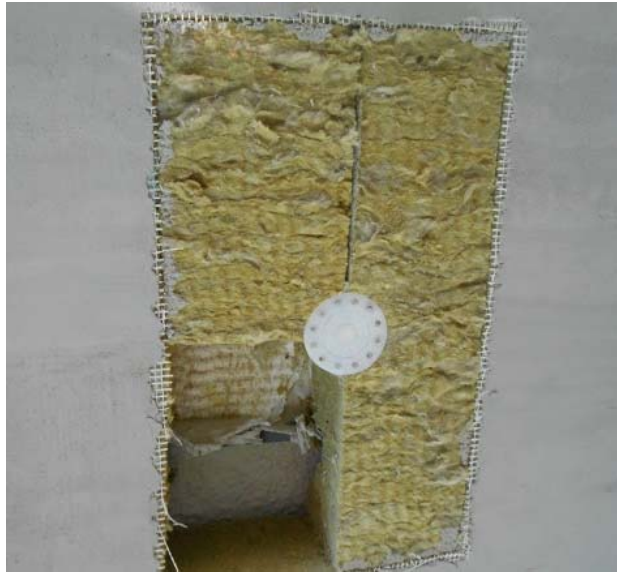
The existing facades are made out of concrete cavity walls without insulation. In order to comply with the of the national regulations, a new external insulation was installed made out of 10 cm thick rock wool panels anchored to the concrete walls. A coating with fiberglass mesh and acrylic coloured mortar protects the façade solution.

Figure 23 – Mineral wool insulation

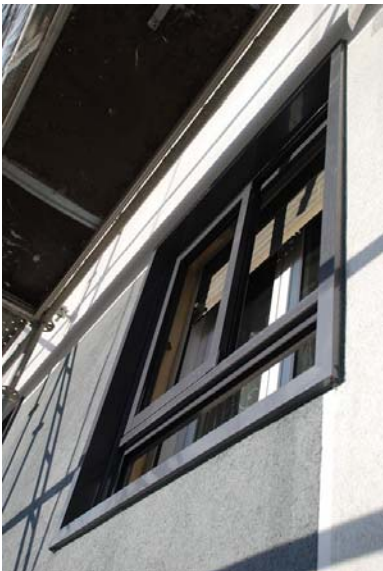
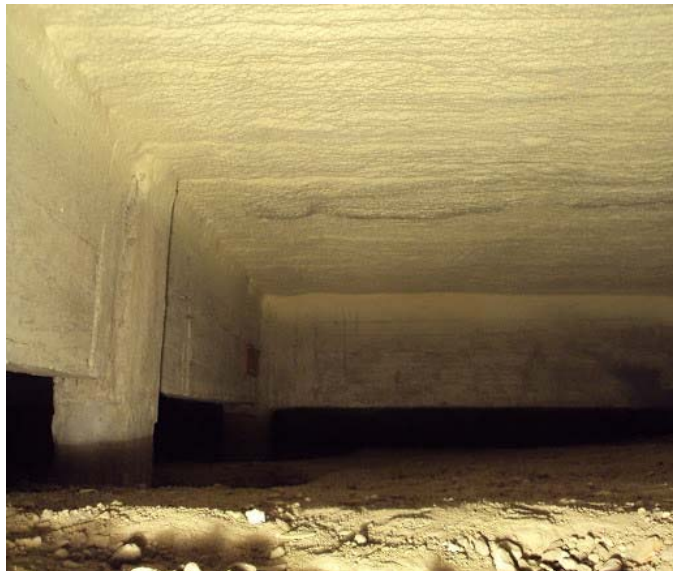
Figure 24 – new windows installed (left) and polyurethane insulation installed in the basement (right)

New windows were installed from the outside on top of the existing ones, without entering the apartments. The existing roller shutters were also left in place minimising the discomfort for the inhabitants.

The 4/10/4 mm, double pane, low-emissivity glass, dark grey lacquered aluminium windows are flux mounted onto the new insulation.

The building has no garage nor lumber rooms below the ground floor dwelling. An empty gap with a height of about 1.4 m separated first apartment from grade. Polyurethane foam with a thickness of about 5 cm and density 35 kg/m<sup>3</sup> was sprayed onto the lower surface, to insulate and to partially cut thermal bridges (Figure 24 right).

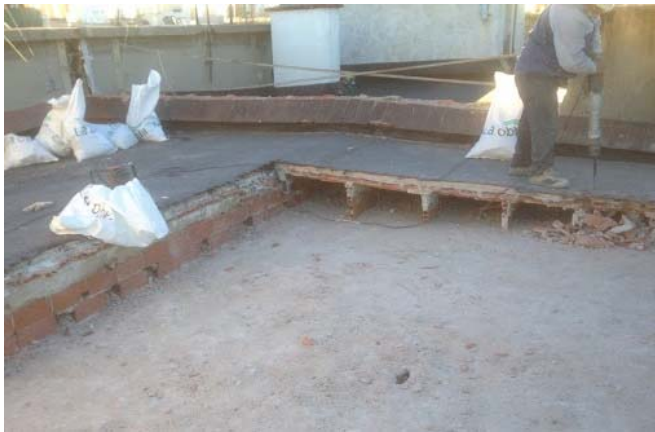
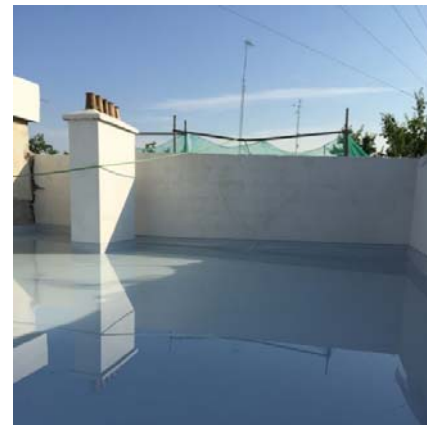
Figure 25 – Flat roof before and after water proof coating deposition

The existing “catalan” cover was dismantled and the remaining structure was reinforced with an added concrete structure, to avoid any future structural failures. The water proof insulation was guaranteed with a geotextile polyester foil (300 g/m<sup>2</sup>) covered with a 1.2 mm PVC-P coating reinforced with fiberglass.

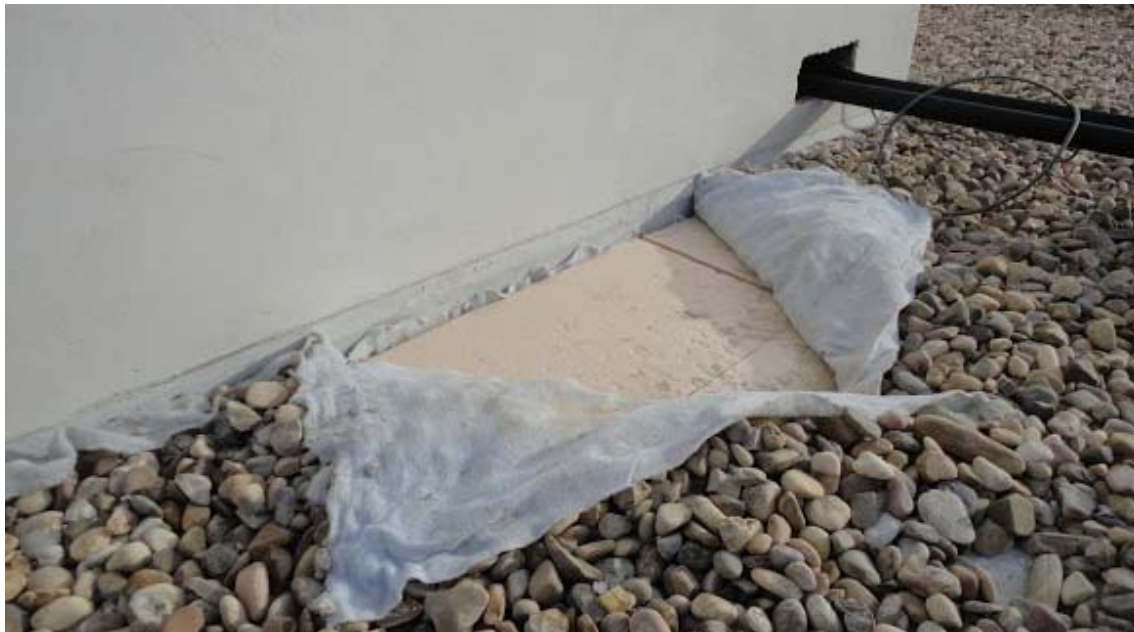
Figure 26 – XPS roof insulation

A 60 mm XPS insulation was installed, again protected with geotextile protection and gravel.
