4RinEU

Reliable models for deep renovation

D5.3

Report on deep renovation packages as tailored and implemented in the demo cases

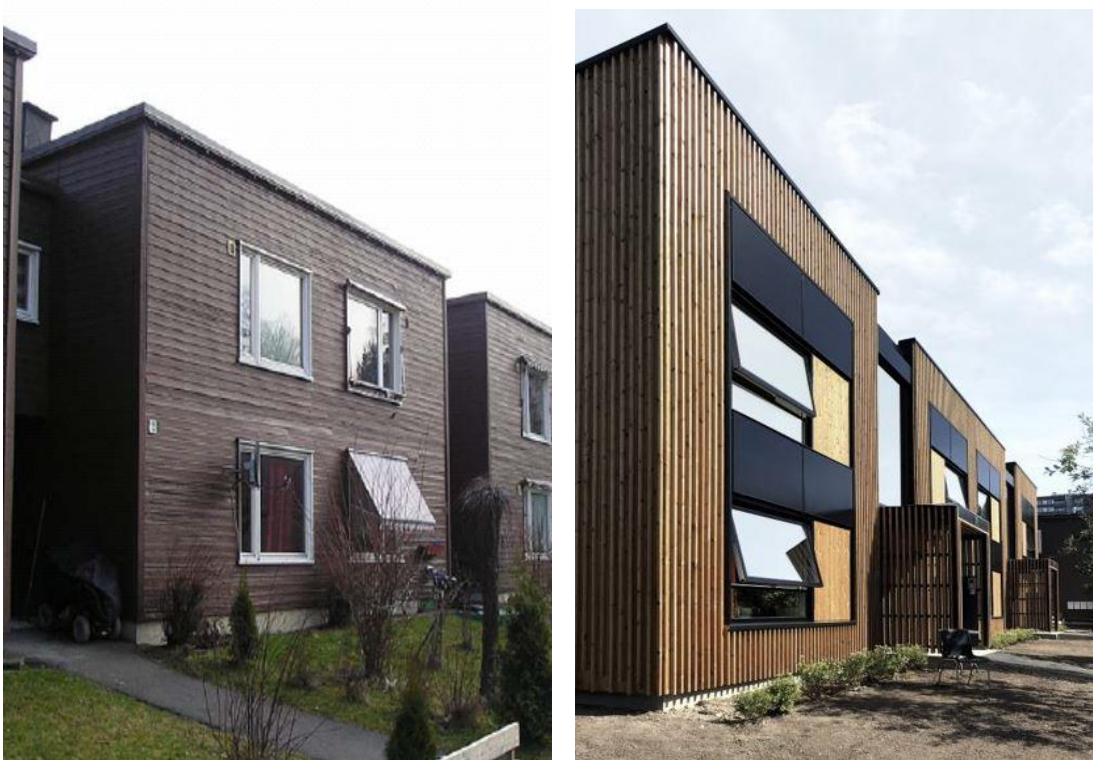
Figure 6: Pictures of Haugerudsenteret 17-19 before renovation (left) and after renovation (right)

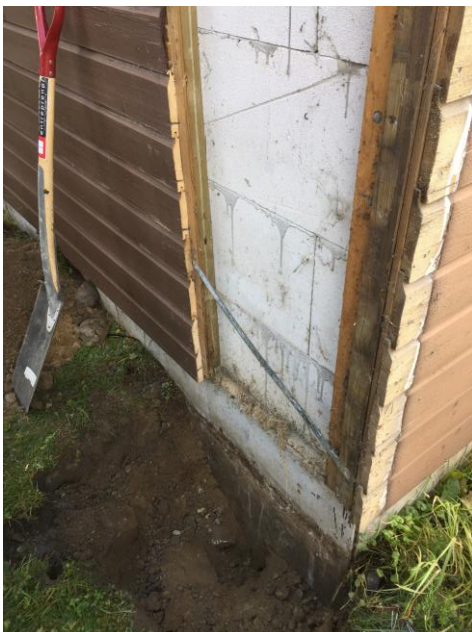
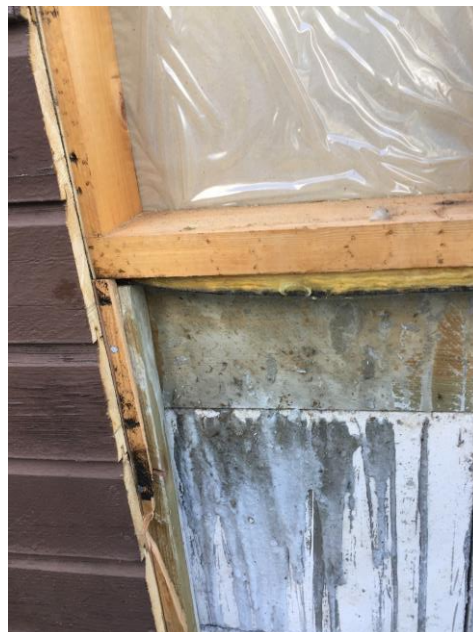
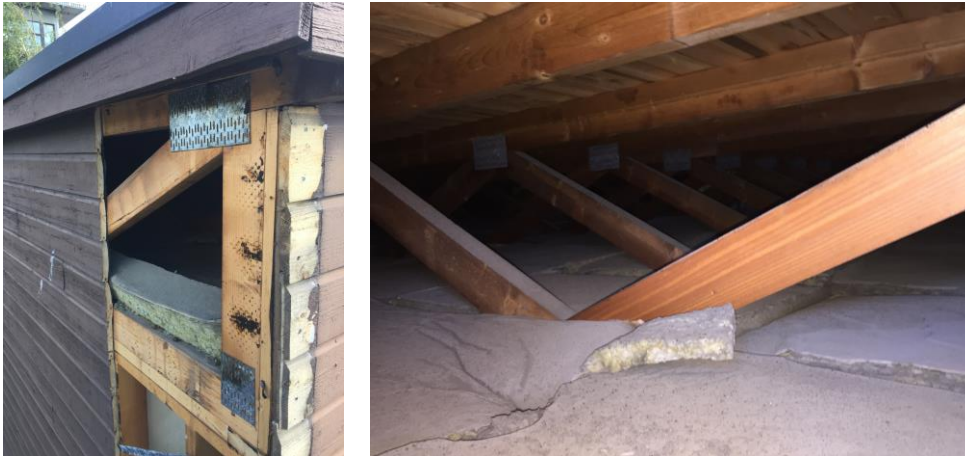
Figure 11: The façade was opened, and the state of the load-bearing constructions was analysed. The aerated concrete bricks are clearly visible. The outer wall does not seem to have major damages or faults. The state analysis shows that the construction is in good shape, with no sign of moisture damages.

The main conclusion from the inspection was that the state of the building was overall good. There was no sign of moisture damages, and the outer wall did not have any major damages or flaws. The state of the cladding was such that the cladding did not have to be removed. Minor faults were locally repaired or removed. The existing cladding was kept and built into the renovated outer wall.

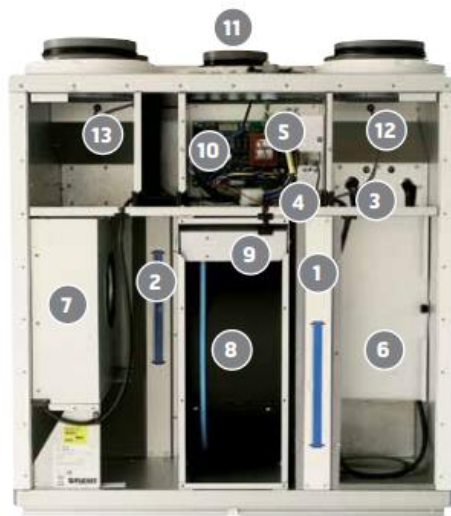
General picture shows UNI 3
(left model with heating element)

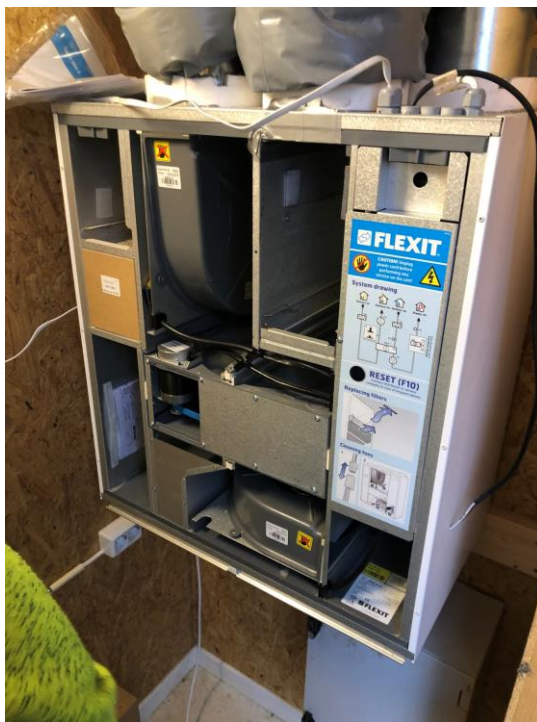
Figure 17 Air Handling Unit (AHU) Flexit Uni 3

The air handling unit includes standard filters, supply- and exhaust air fans, see Figure 17. Rotary heat wheel and electrical heating element ensure stable inlet temperature (19 °C). No cooling installed, which is the common solution for new apartments in Norway.

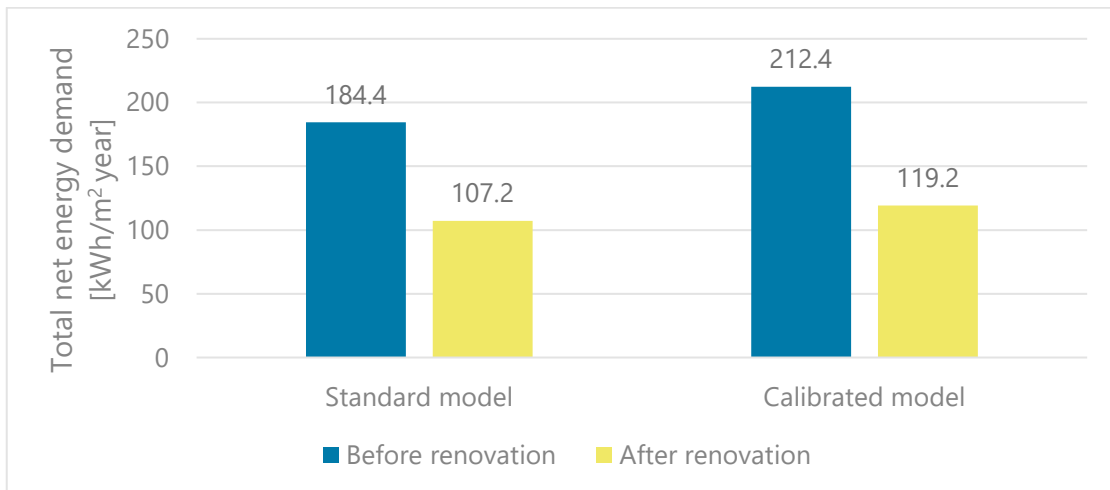
Figure 19: Total net energy demand before- and after renovation

Figure 19 summarizes the achievements for delivered energy for the standard and calibrated model. More detailed can be found in D5.2 section 2.6.

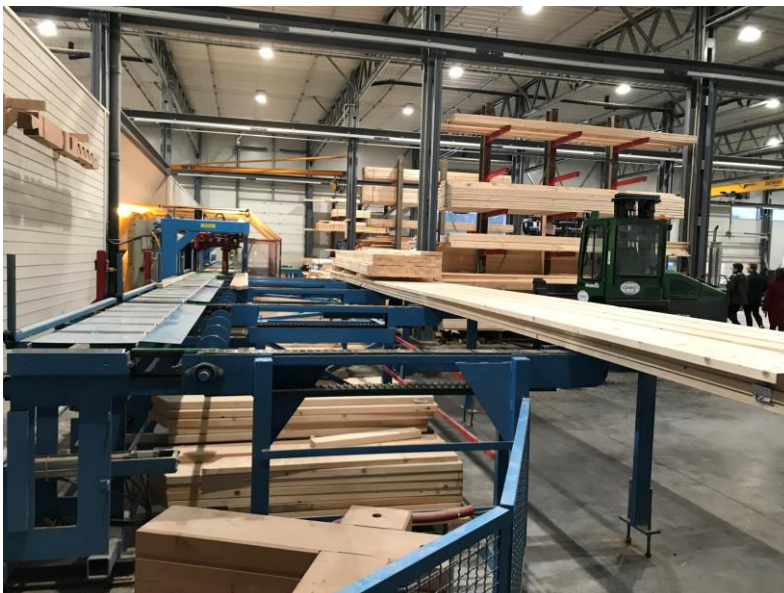
Figure 20: Lindal's CNC saw for precutting of studs and beams

Lindal's factory has automated computer-controlled cutter machines (CNC machines) for pre-cut of studs, beams etc. The assembly of studs, sills, and beams in the elements are done manually using a laser-guided system on a production table, se Figure 21. The elements are insulated, and other layers and exterior cladding added. A wrong delivery of parts of the cladding and too long re-ordering time led to on-site mounting of cladding on some north façade elements as seen in Figure 34.

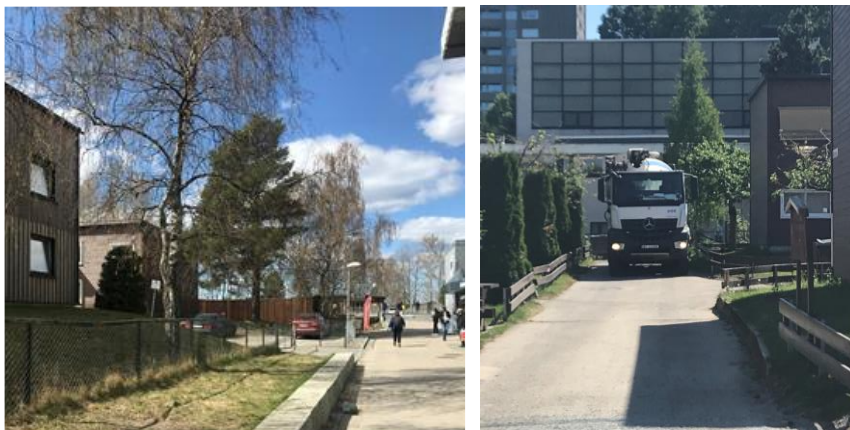
Figure 23: Narrow access from back side. Challenging curves to enter front side

Trucks can drive through the production area and loaded. Elements were transported to the site just in time. The construction site is narrow, with a challenging last curve before entering the very site, and short distance to neighbouring buildings. Trucks and crane were carefully chosen for the task and no problems occurred.

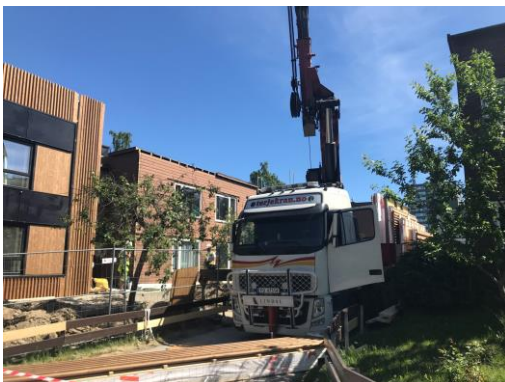
Figure 24: Narrow site and short distance to neighboring buildings

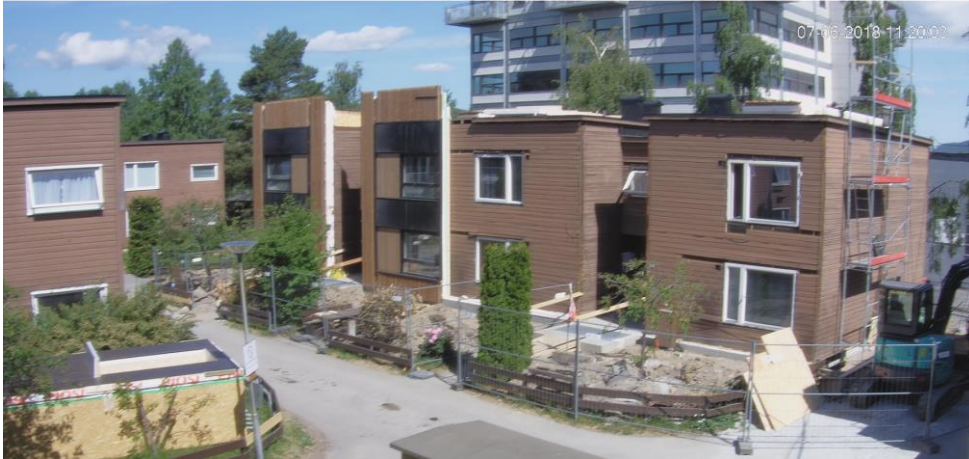
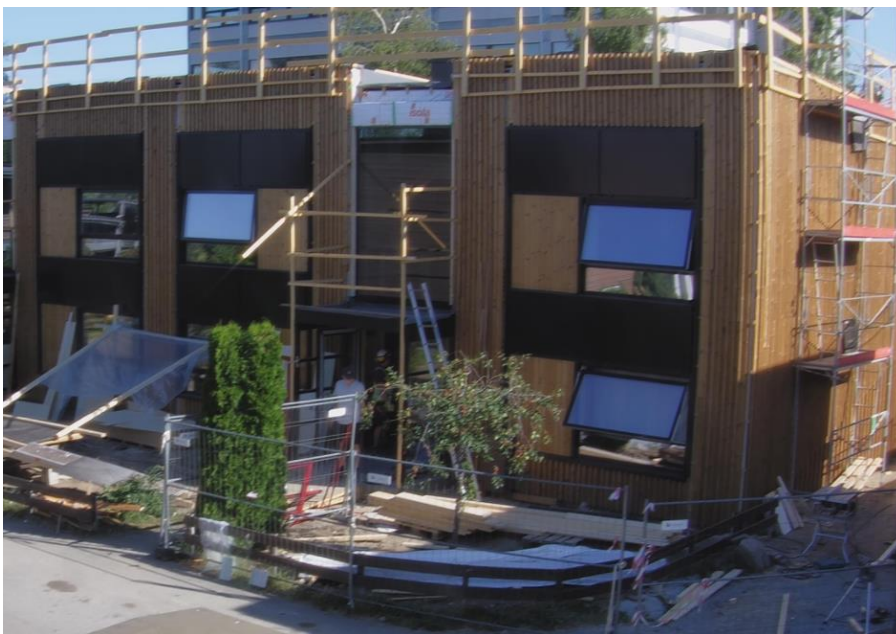
Figure 25: Hagerudsenteret 17-19 during renovation June 2018. Half of the building was renovated at a time. The upper picture right side show existing building with dismantled protruding parts of roof and windows.

The construction site was rigged during week 23 of 2018. Existing entrances were dismantled. Groundwork for foundations was prepared around the building. At the same time, any object penetrating or mounted on the building envelope, such as electric cables, water pipes for outdoor faucets, ventilation opening and grilles etc., had to be removed to prepare for the mounting of new façade elements.

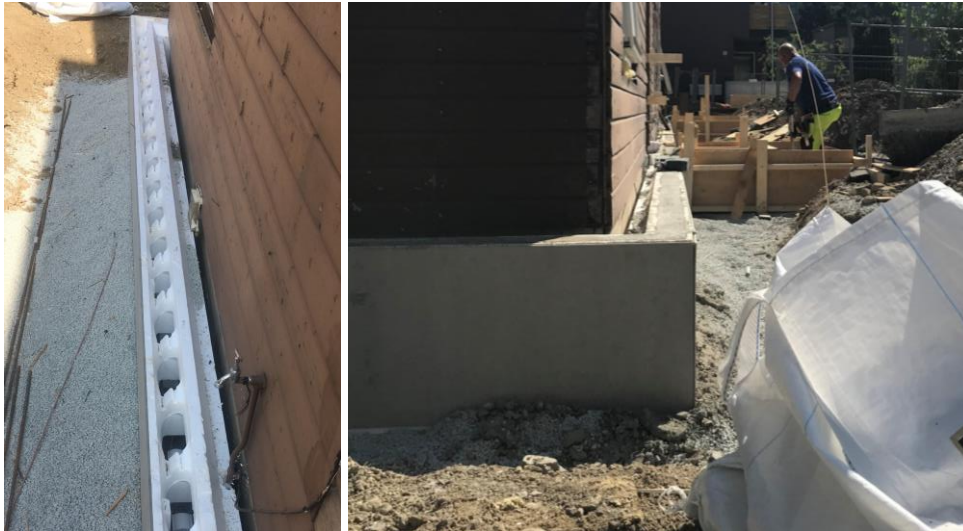
Figure 26: Foundation molds before casting (left) and after filling of concrete (right)

The Styrofoam moulds for the foundation were set up around the building (see figure below) and then filled with concrete. Depending on where to build in Norway, it is common to use horizontal ground insulation outside the foundation to prevent the ground from freezing and causing damages due to expansion of the ground.

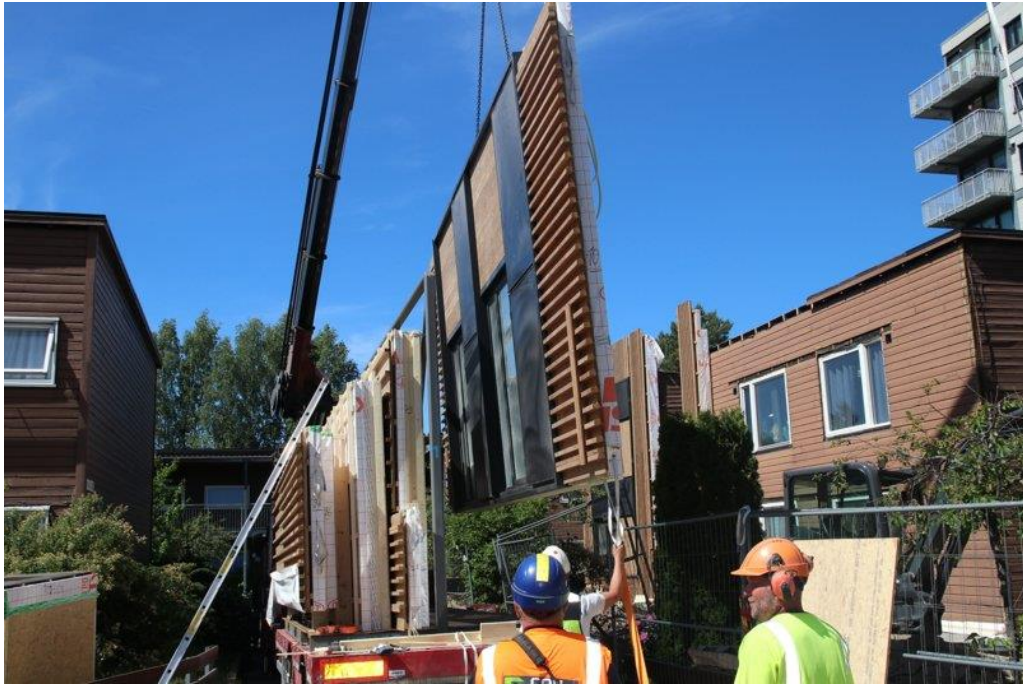
Figure 27: installation of south façade elements with PV

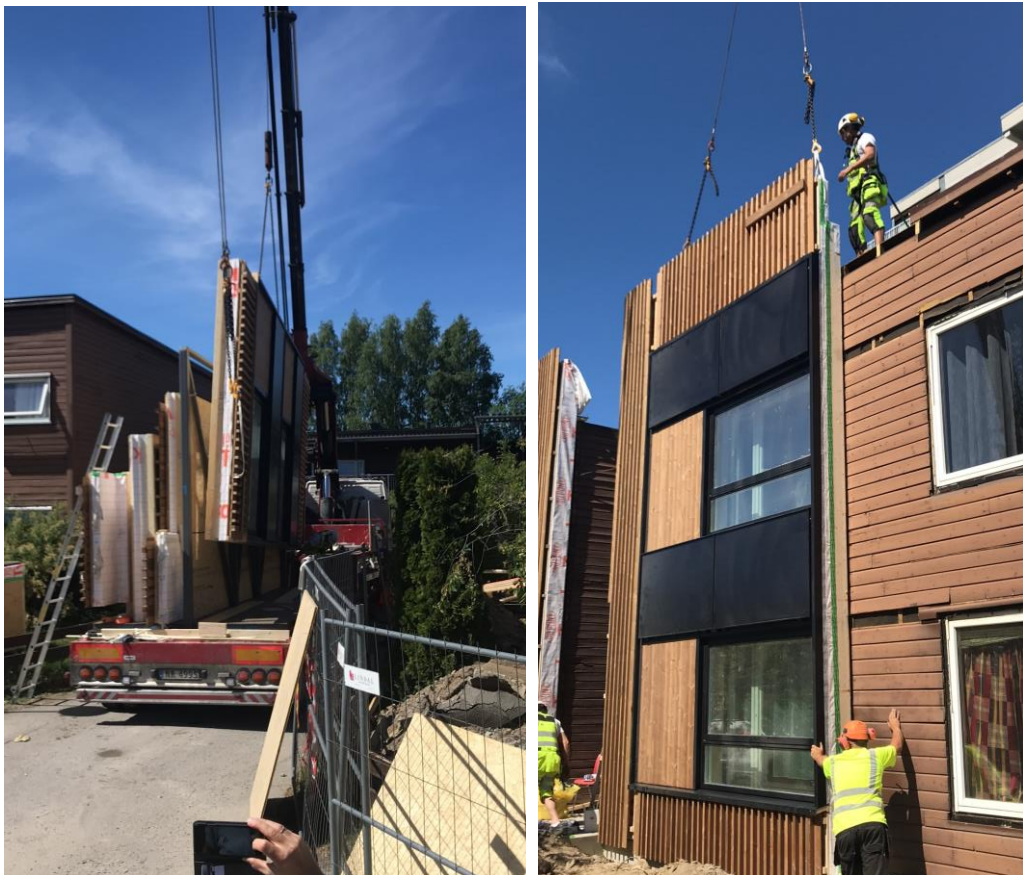
Figure 28: Safe craning and careful securing of element, right on spot without tolerance problems

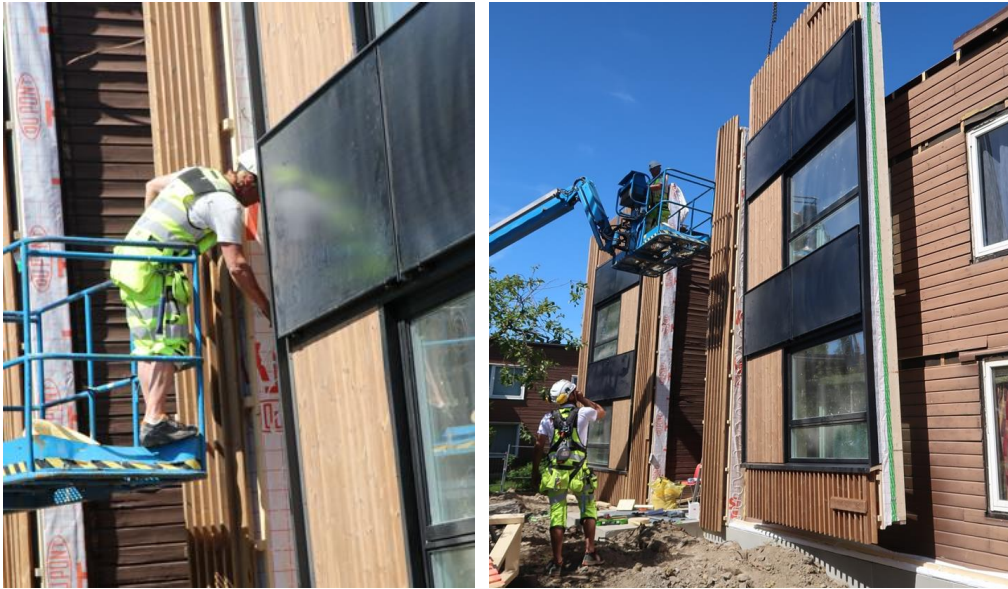
Figure 29: Important details: Airtight connection to other elements and foundation

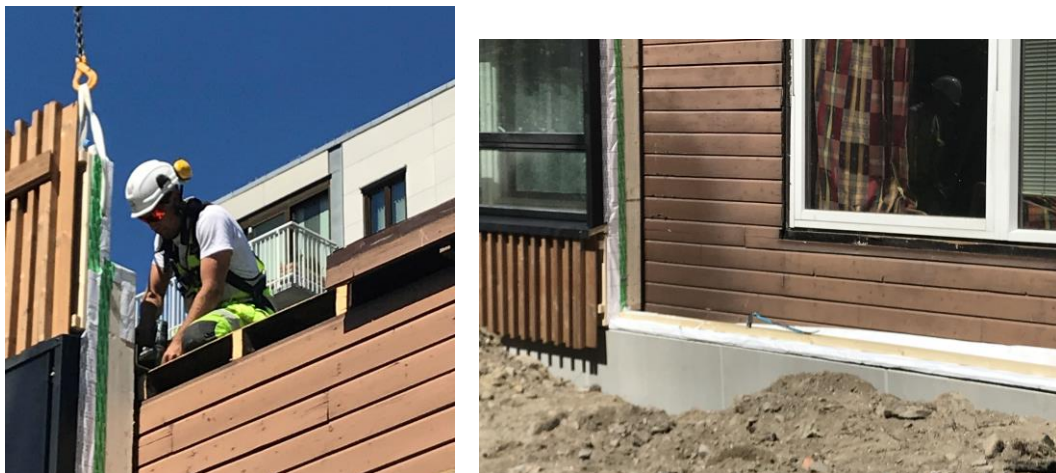
Figure 30: Details – securing of wall element and wall element mounting on new foundation

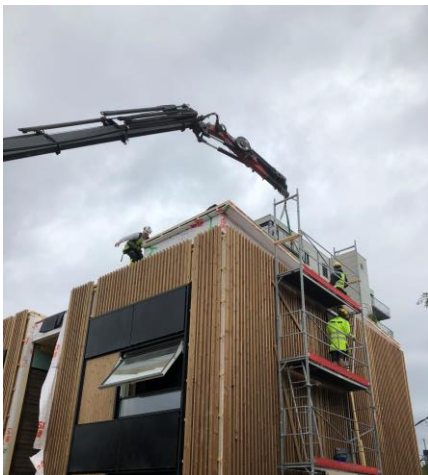
Figure 31: Mounting of the roof construction. Photo: Boligbygg

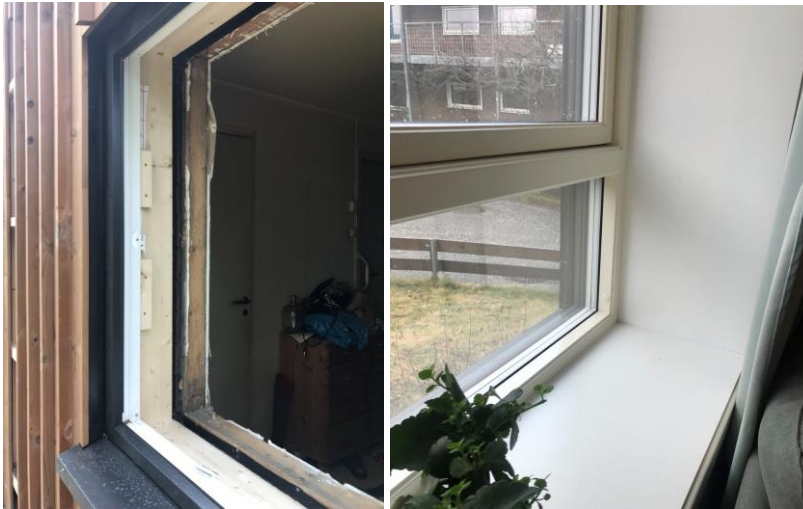
Figure 32: Installation of the windows in the prefabricated elements

When the facade element with new windows had been installed, the old windows needed to be dismantled and removed from the inside. The window bay was then covered with window casement boards and casing. The amount of work inside each apartment related to the replacement of windows was finished within one day. The tenants could stay in the apartments during the whole process since the fire escape routes were never blocked due to renovation activities.

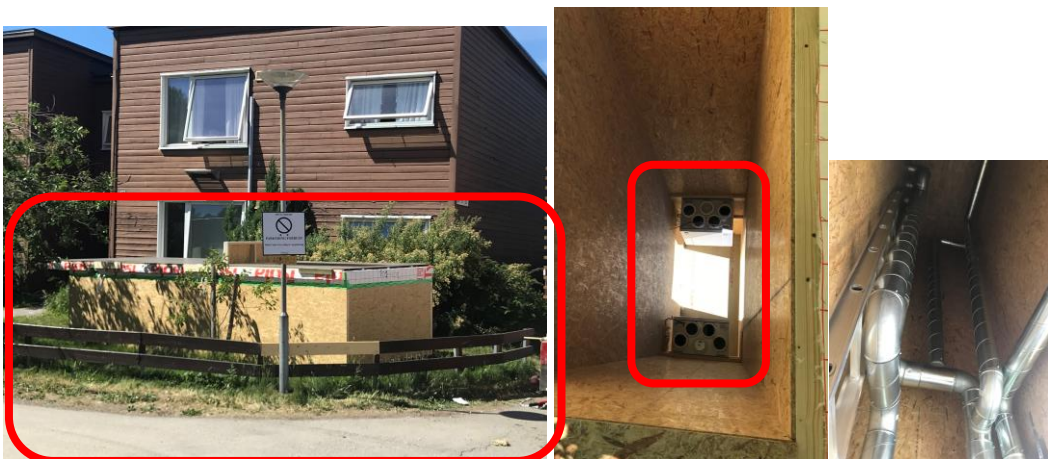
Figure 33: Prefabricated technical room/shaft in front of the building before installation (left). Technical shaft (center) with air handling units seen from above before installation of ductwork, and seen from below after installation

The prefabricated technical room/shaft was placed in front of the building before mounting on the north facade. The installation of the ventilation system with air handling units and ductwork was this time done at site.

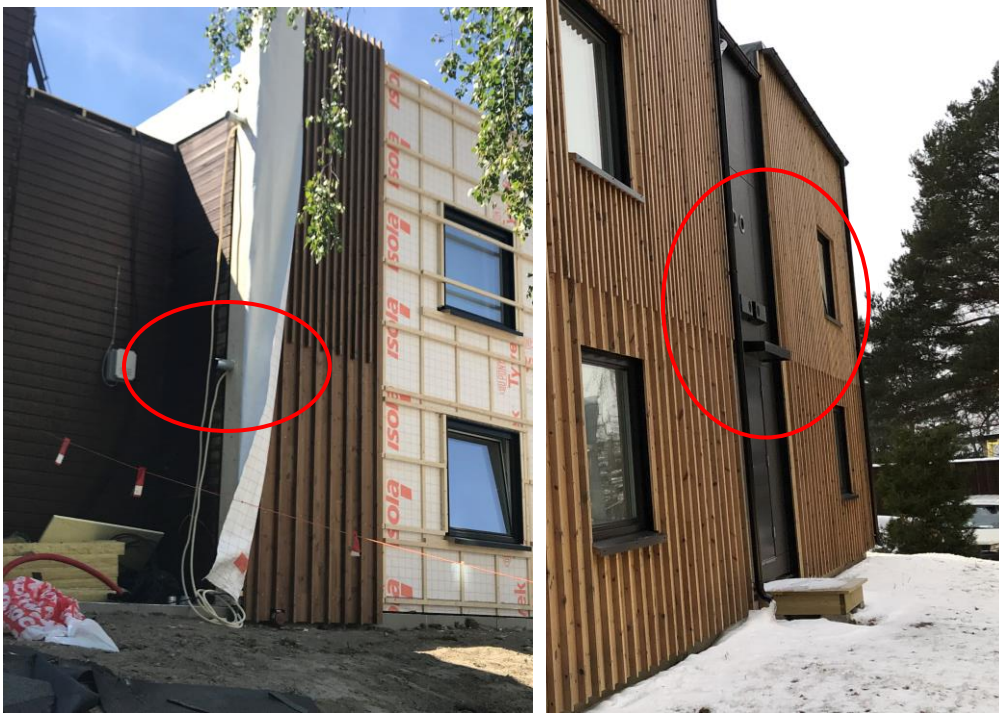
Figure 34: Ventilation duct to bedroom included in-wall element (left) and Entrance to technical room/shaft. Exhaust and inlets can be seen above the door (right).

Ventilation supply ducts from the technical room to the bedrooms were installed off site in the north façade elements as seen in Figure 15 and Figure 16. The supply air for the living room and the exhaust ducts from the bathroom and kitchen were installed in the stairways using a traditional approach.

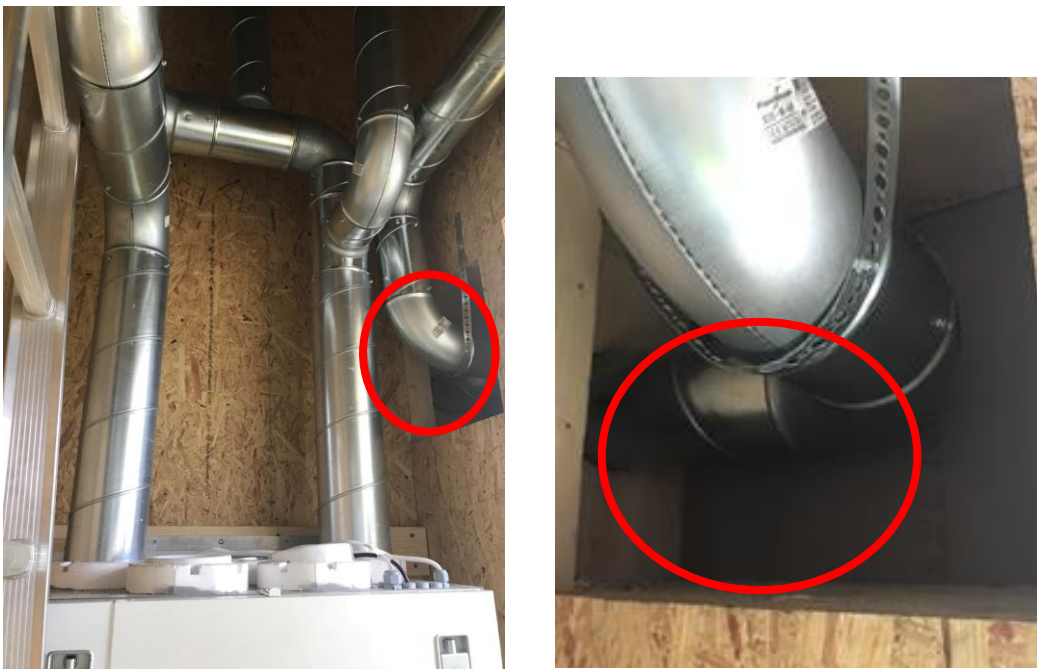
Figure 35: Ventilation ducts in the technical room / shaft. Left: Top of air handling unit is visible, right: magnified while connection to supply air duct in wall elements.

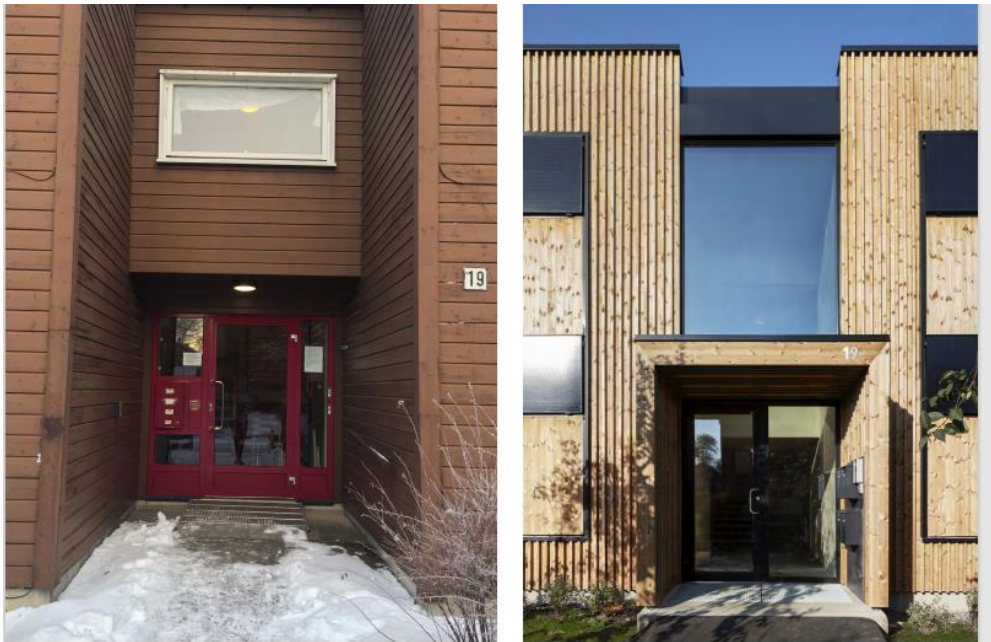
Figure 36 Left: old entrance. Right: new entrance.

Figure 36 shows the entrance before and after renovation. The new façade of the stairways was traditionally constructed on-site and not with prefabricated elements. As seen in the pictures below, the new wall consisted mainly of glass, with the glass entrance door on the ground floor and a large window on the second floor. The interior of the stairway was kept as is.

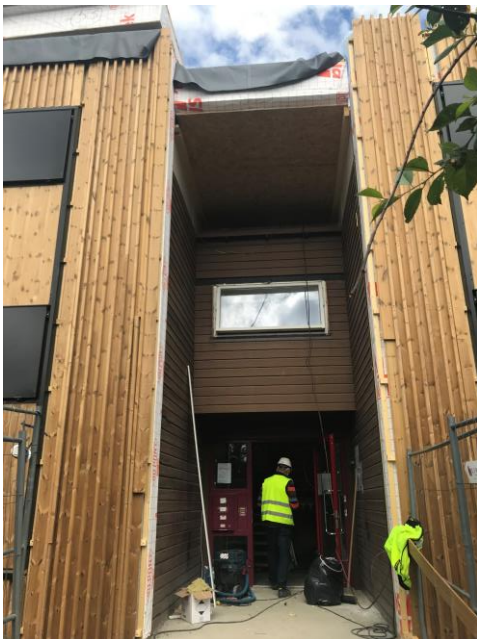
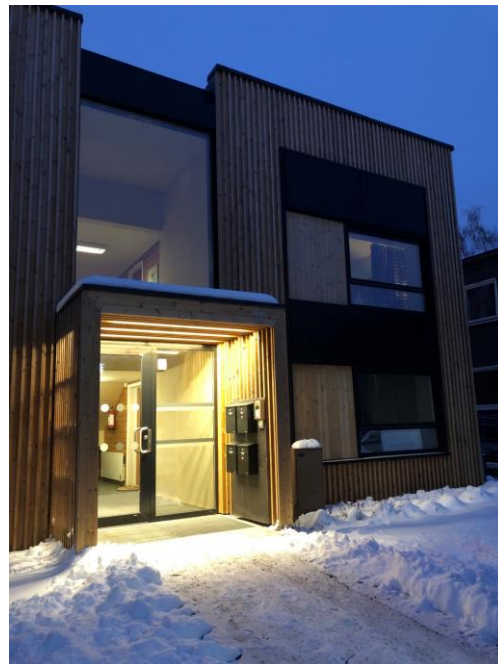
Figure 37: Above: Entrance area. Old red entrance door and wall/window above can be seen between new elements. The new entrance door is moved to align with the new façade. Below: New entrance area seen from the open space at the position of the originally window

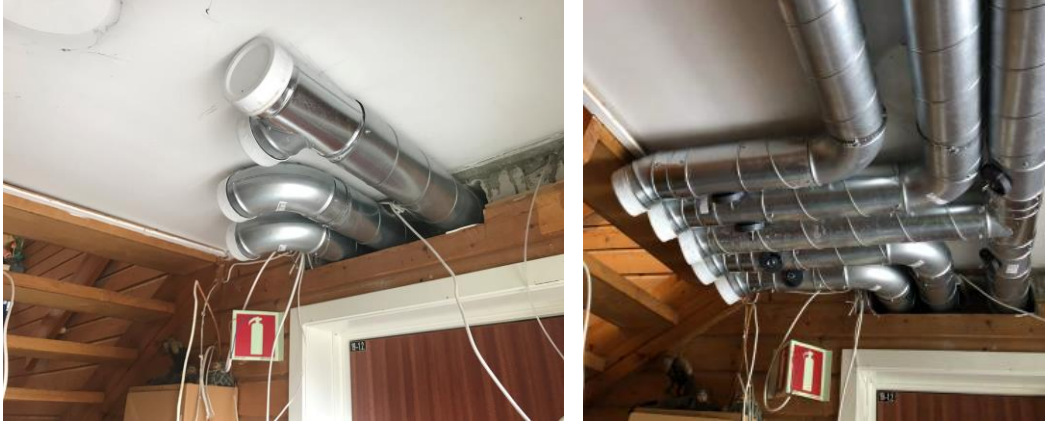
Figure 39: Ductwork from entrance in apartment to main entrance, to be connected to ducts underneath the stairway

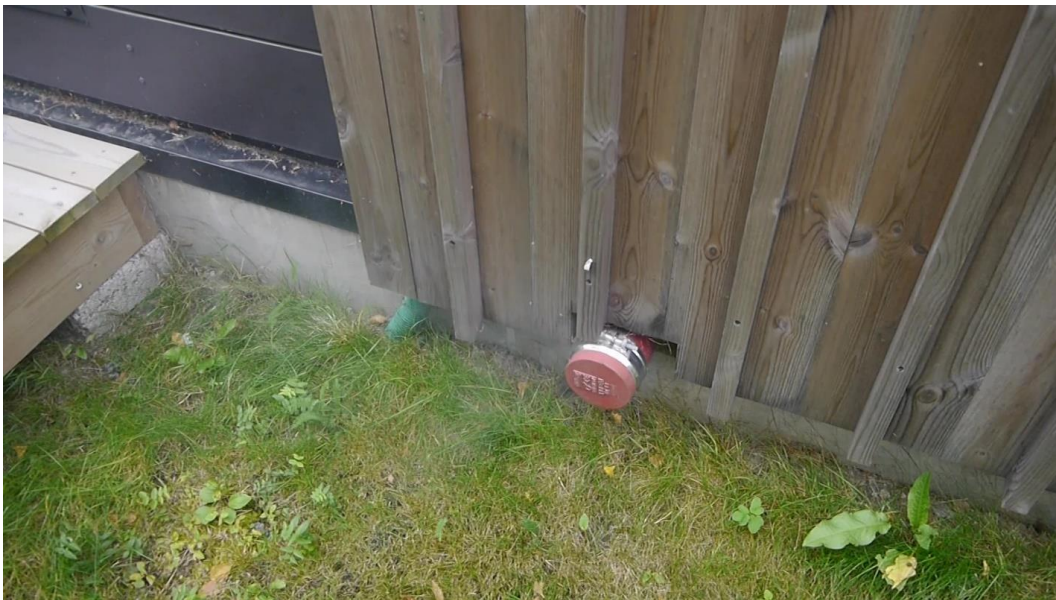
Figure 44: Smoke in the passage for downpipes, before sealing

coverings made the exact observation of leakages difficult. Minor leakages were also observed around a few windows and doors. Where accessible, the detected leaks were remediated by expanding polyurethane foam, or with the aid of airtight spun bond polyethylene fabric (housewrap) and tape.

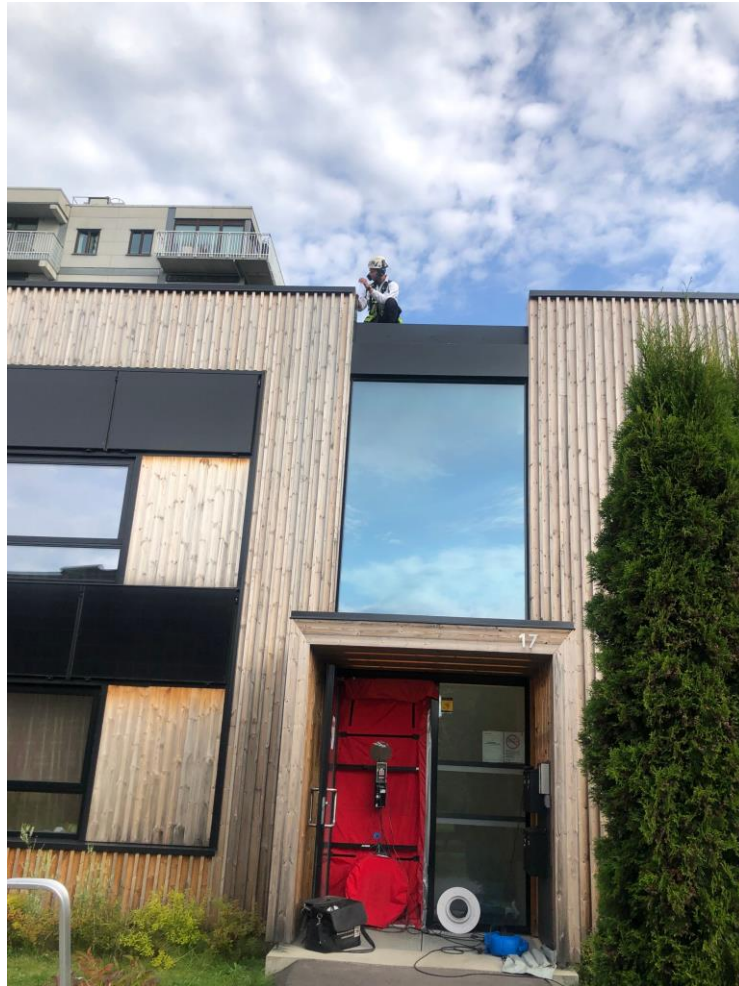
Figure 45: Blower door measurement performing while Lindal personnel is checking the sealing of the roof

After remediation of the accessible leakages, the resulting air leakage from the blower door measurement was 2.82 h^{-1} for Haugerudsenteret 17-19.

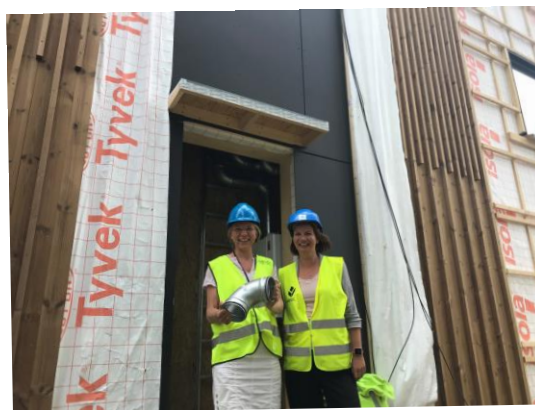
Figure 46: Kari Thunshelle from SINTEF (left) and Vera Lukina (right) outside the technical room inspecting the installation of the ventilation system.

Extract and inlet air were initially placed in a combo unit. Due to contamination problems, extract outlets were moved to a higher position on the technical room external wall.

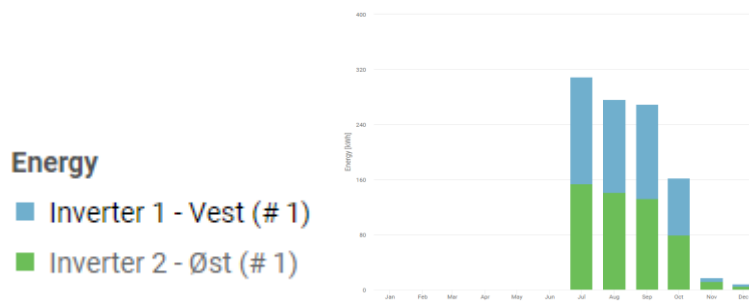
Figure 47: PV production during 2018. The PV panels were fully operational from July

The PV panels, BIPV are fully operating, and live production (5-minute intervals) can be found at www.solarweb.com. There are in total 16 panels, each 1.7 m², and total 27.2 m². The installed power is 4.56 kWp, and the panels are said to have a nominal efficiency of 19.5 %. More information can be found in Deliverable report 5.2 *Concept design and performance targets for the demos*. Indications on production so far for 2018-2020 is presented in the figures below, with a maximum of 400 kWh in April 2019. The systems are working well and performing as expected. Due to restrictions on distributing produced energy to tenants, the generated energy is so far mainly transferred as feed into the grid.

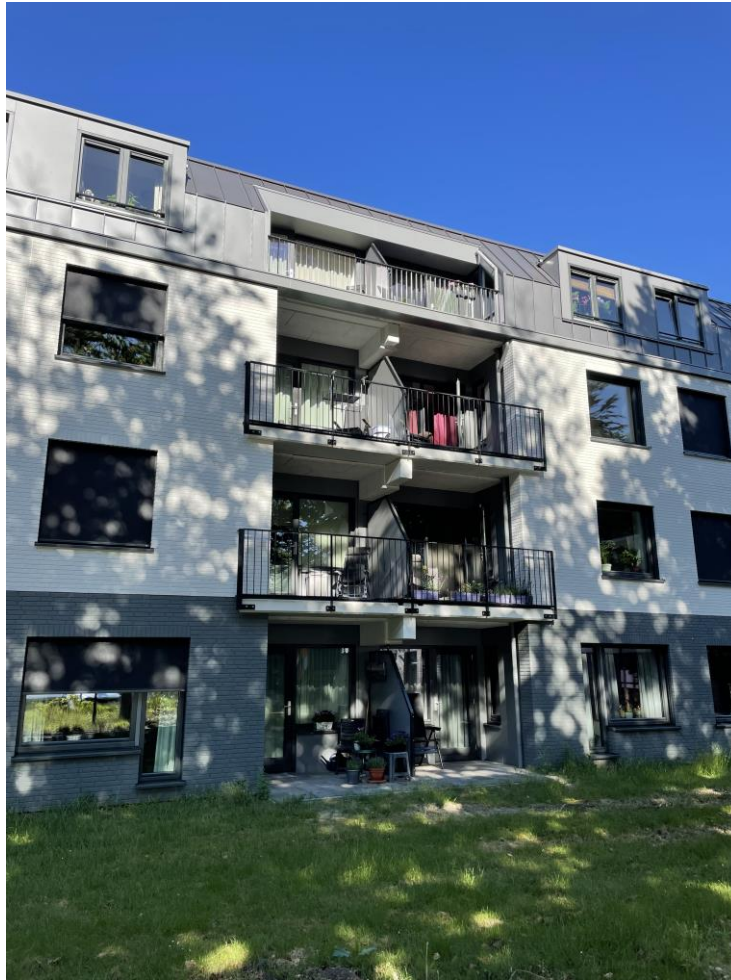
Figure 60 Façade of the 4RinEU demo part: new prefab façade with new triple glazed windows, integrated shading and thermal bridge insulation around the balcony

The 15 apartments in the South-East wing of Marienheuvél have new prefabricated facades with three additionally integrated technologies: shadings, ventilation with heat recovery and summer night ventilation. The Climarad ventilation unit has a specific summer night ventilation mode which activates when needed. This can also be manually done. In addition, a new tilted window has been introduced to have more window operation modes.

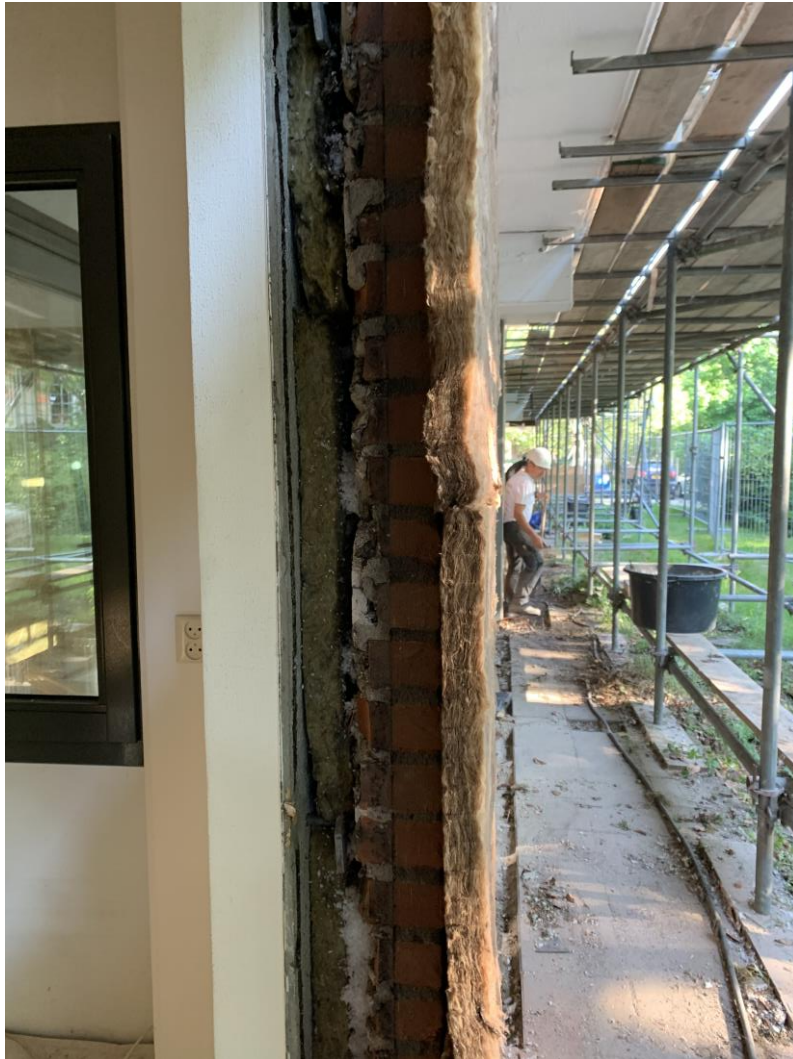
Figure 61 The existing insulated cavity has been post insulated. The exterior wall has been cladded with insulation before the prefab facades were mounted.

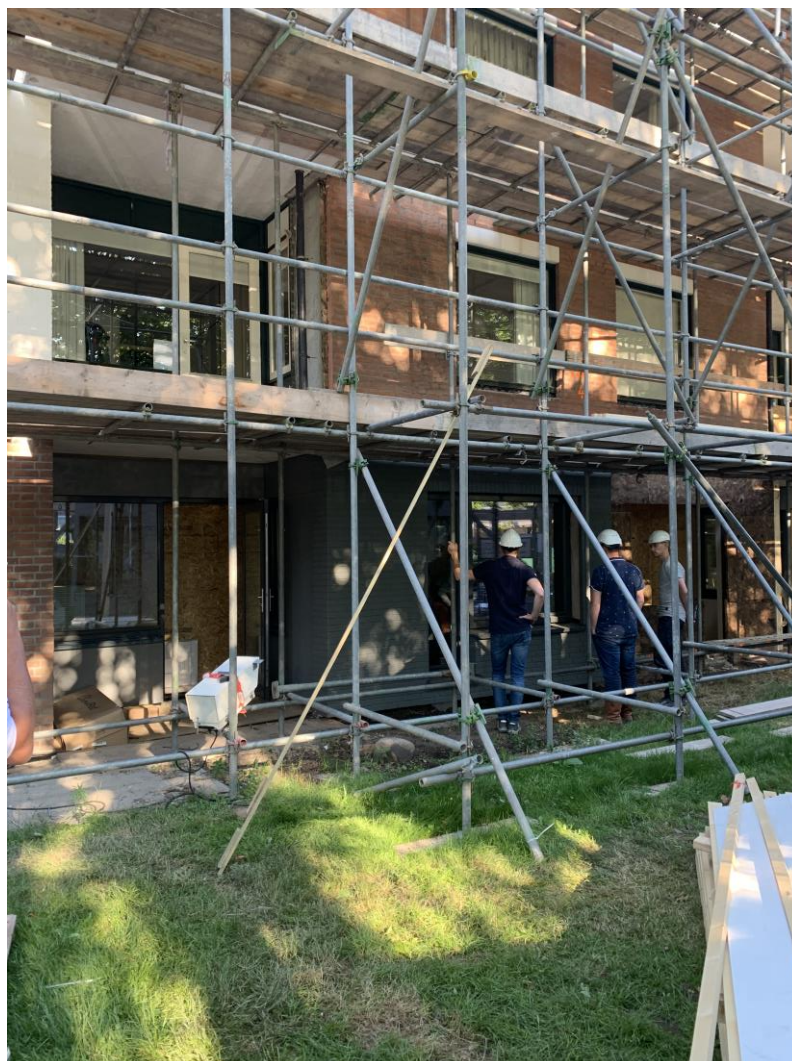
Figure 62 Scaffolding has been placed to renovate the roof and the balconies. The scaffolding has been placed on a distance to allow the mounting of the façade elements.

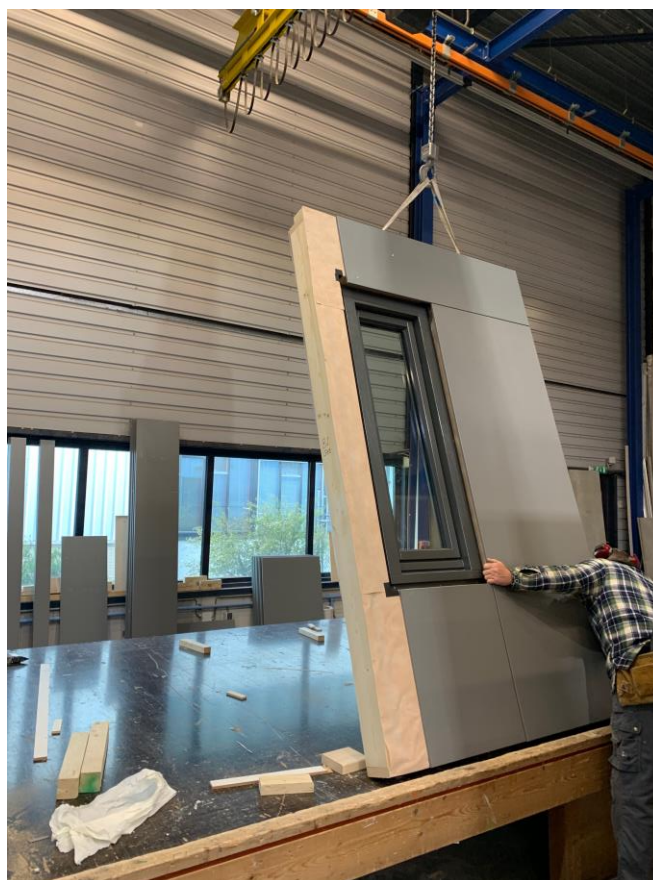
- frames are included for windows mounting, combined with a sun protection device.

Figure 63 Window frames and glazing were pre-installed in the factory.

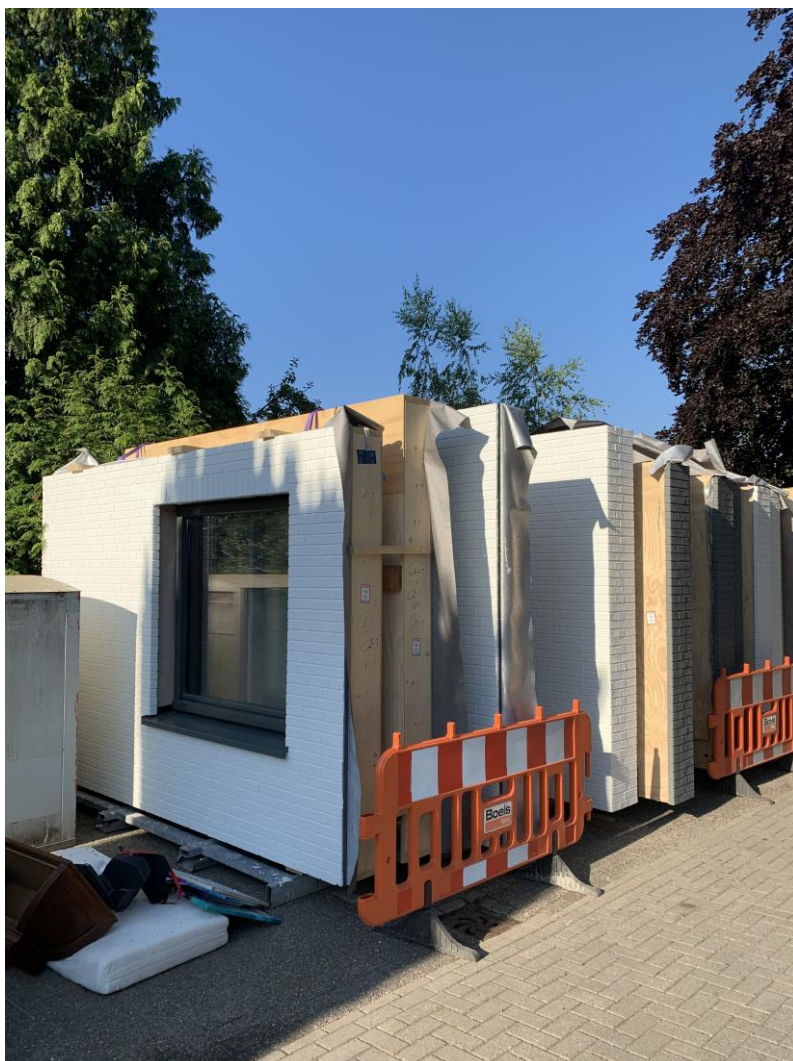
Figure 64 Prefabricated elements delivered to the site and waiting to be mounted

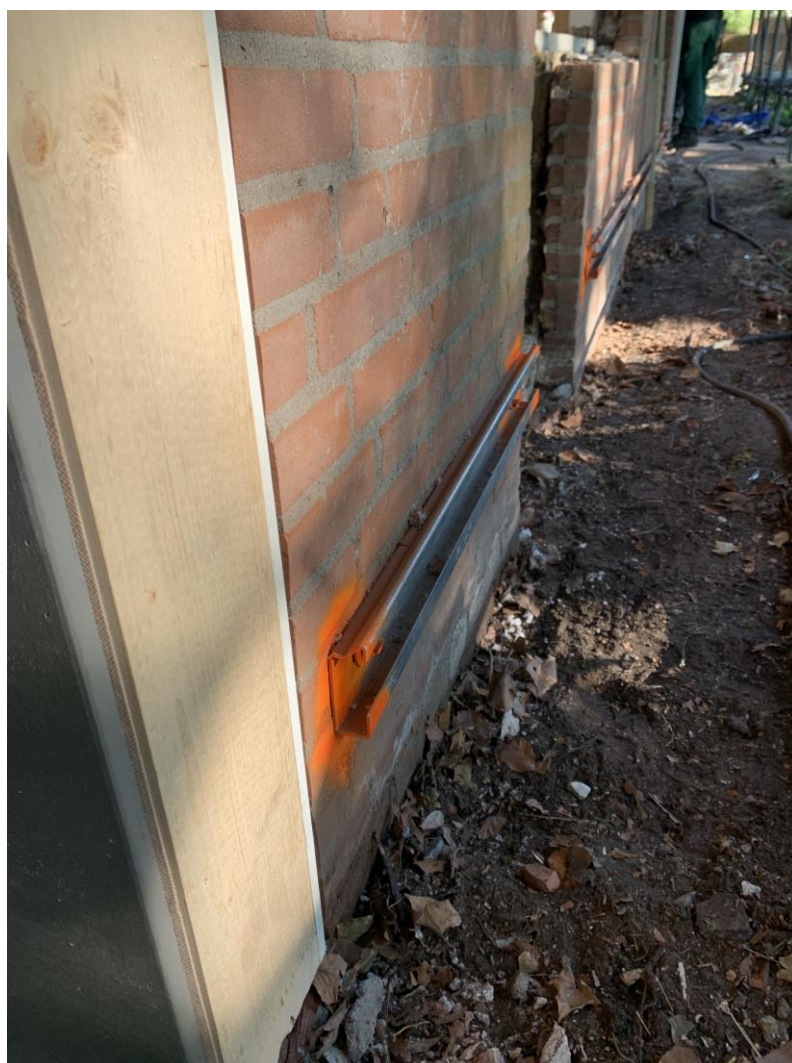
- on site, a suspension structure is pre-set on the existing façade and installed consisting of a mounting rail that is attached to the existing façade with screwed anchors (after checking, by means of tensile tests, that the existing structure has a sufficient bearing capacity for supporting the new façade).

Figure 65 The first Hilti rail mounted on the exterior of the cavity wall construction.

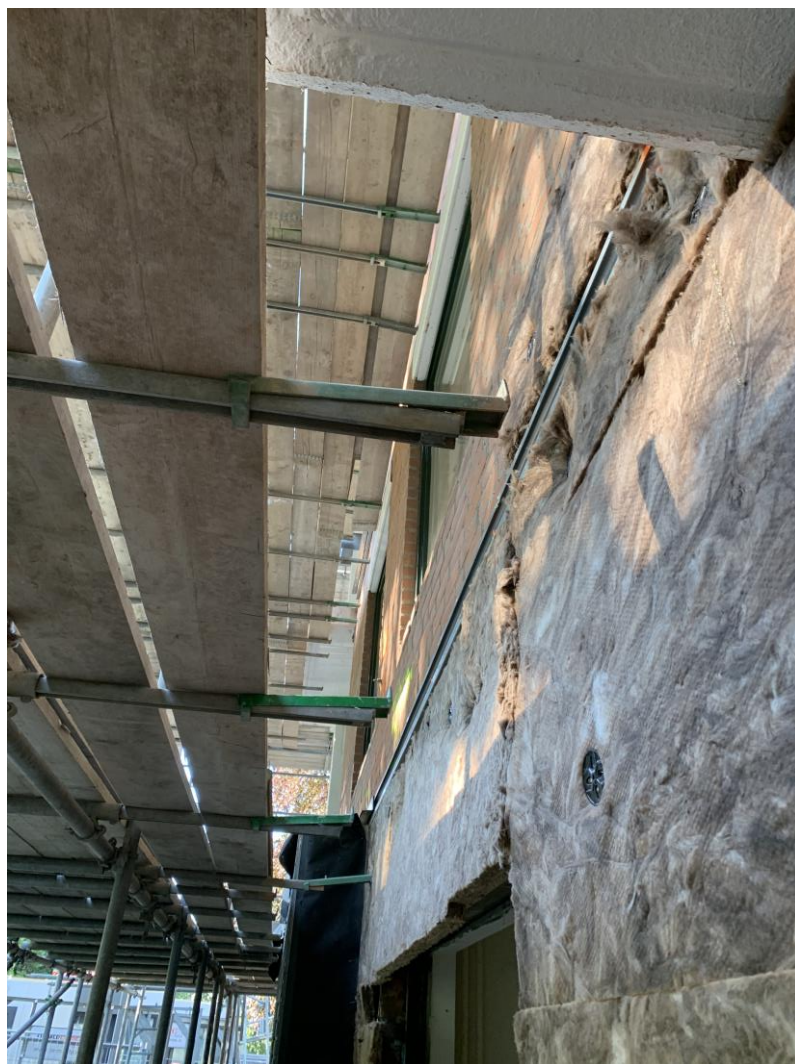
Figure 66 Hilti railing system is mounted on the exterior façade. This method has been successfully used in previous project by Prefabfabriek Culemborg.
