4RinEU

Reliable models for deep renovation

D5.3

Report on deep renovation packages as tailored and implemented in the demo cases

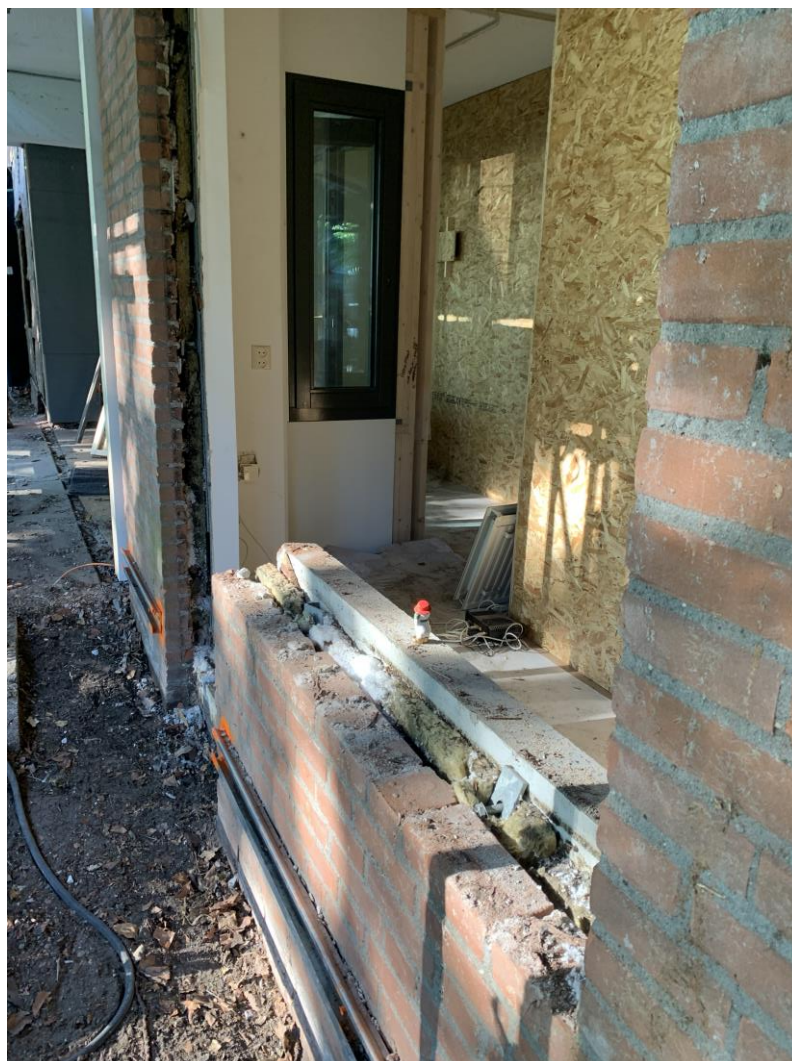
Figure 67 During two workweeks a temporary wall was constructed between the living room of the tenants and the work area for the façade renewal and prefab façade application.

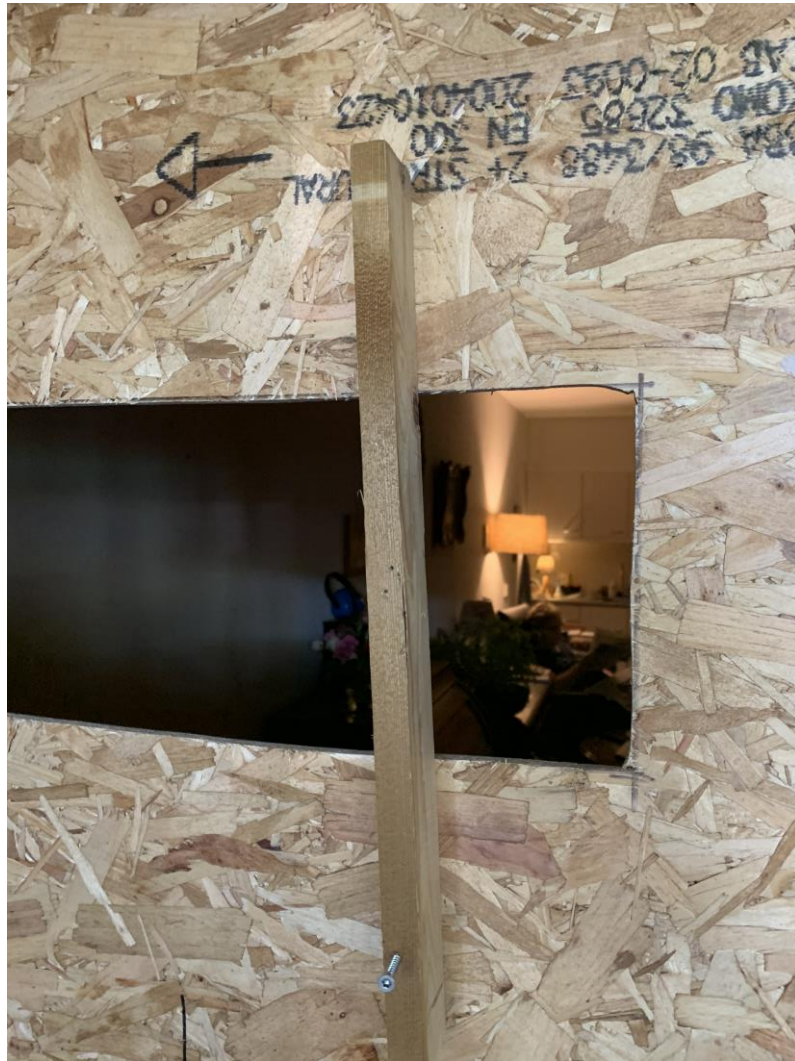
Figure 68 Very small daylight opening in the temporary wall.

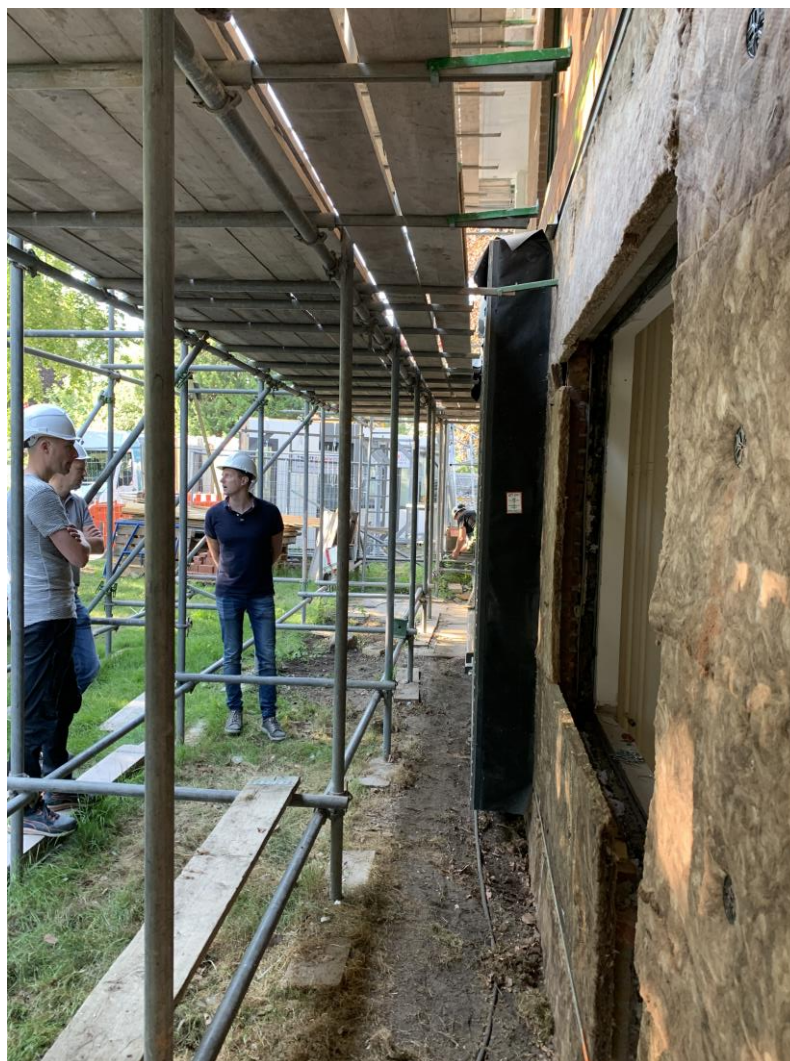
Figure 69 The prefab elements have been mounted horizontally. This reduces the disturbance and presence of construction workers. The original plan was to mount the elements vertically, which is easier from a technical perspective. The argument of tenants disturbance prevailed because of pandemic prevention measures.

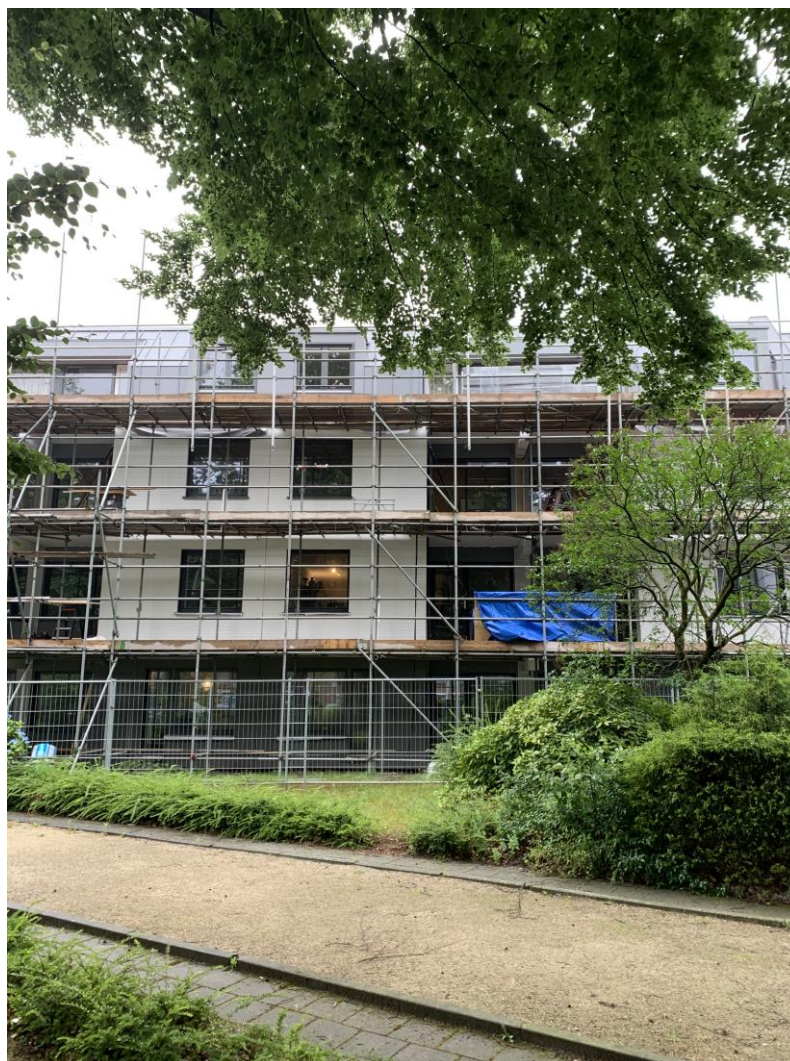
Figure 70 Mounted prefabricated façade elements after a two-weeks period for all 15 apartments.

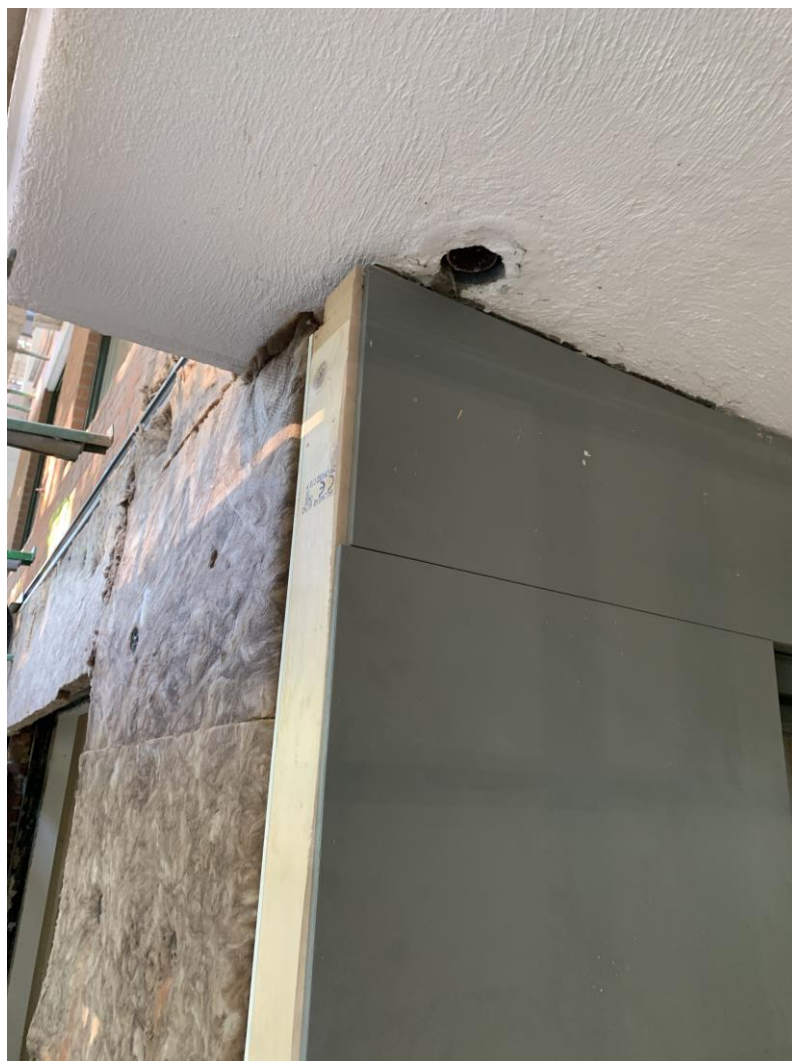
Figure 71 The width of the façade element adjacent to the balcony has been designed to leave space for the rainwater gutter.

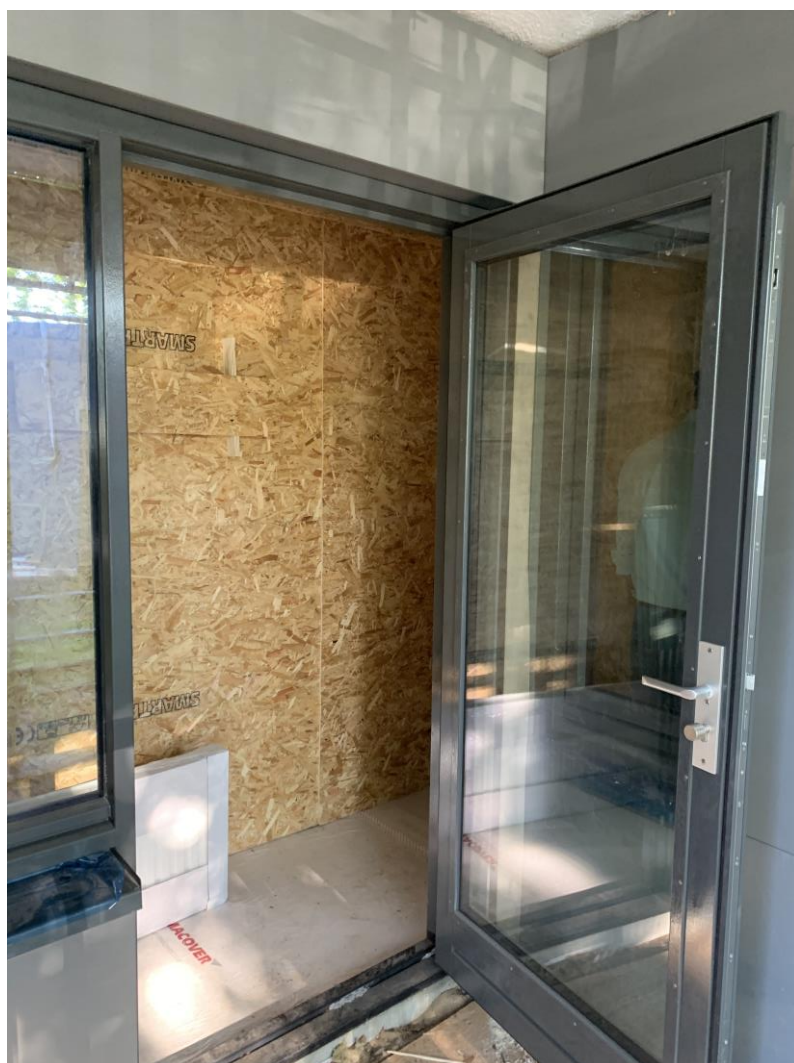
Figure 72 The temporary separation wall between the new balcony façade and the apartment.

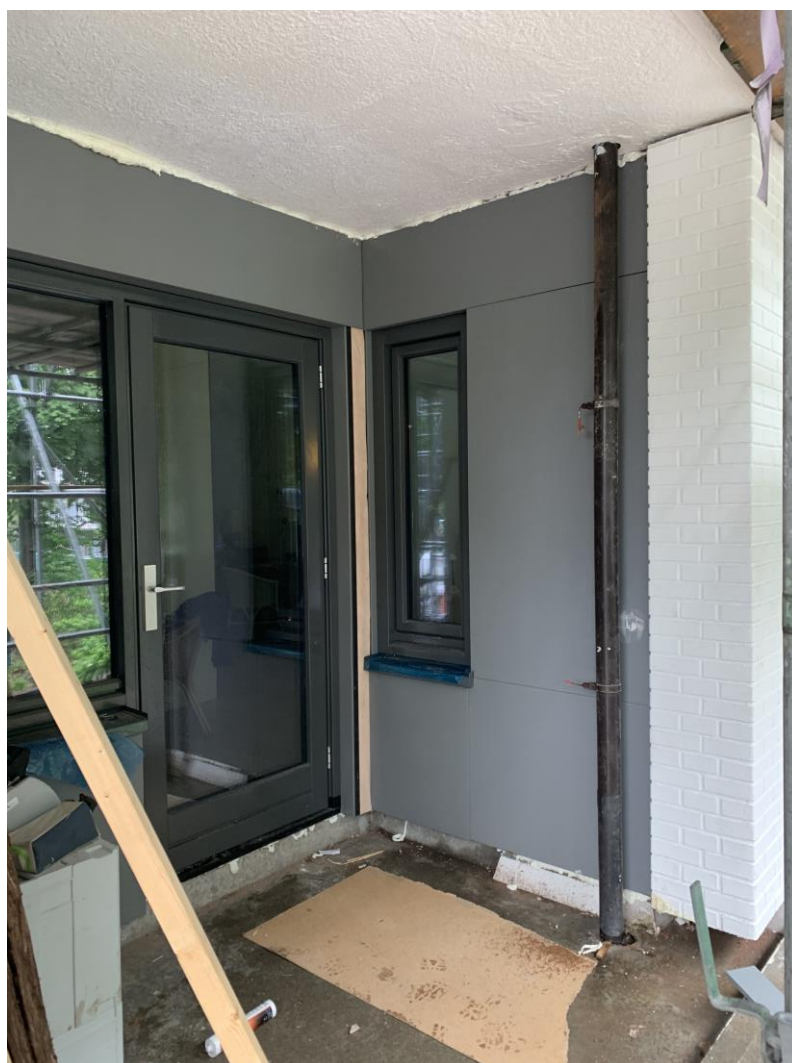
Figure 73 Installed prefab façade elements around the balcony. Afterwards thermal bridge insulation has been added on the floor and ceiling of the balconies.

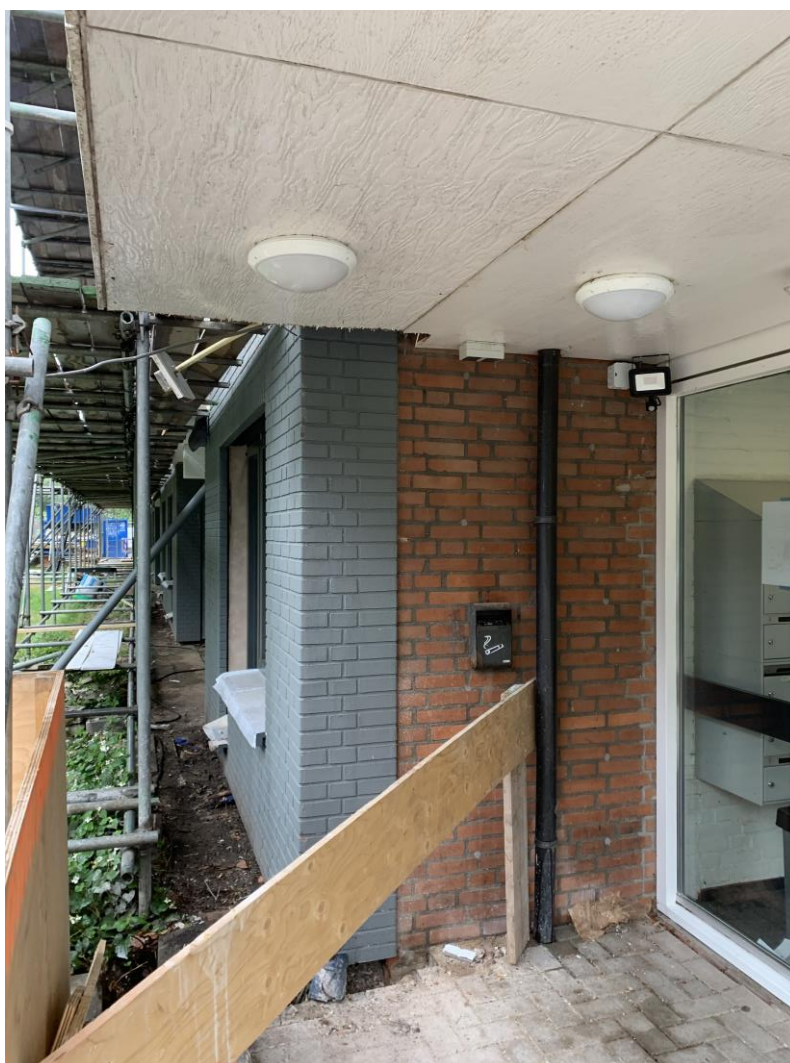
Figure 74 Connection of prefabricated façade and cavity wall façade near the building entrance

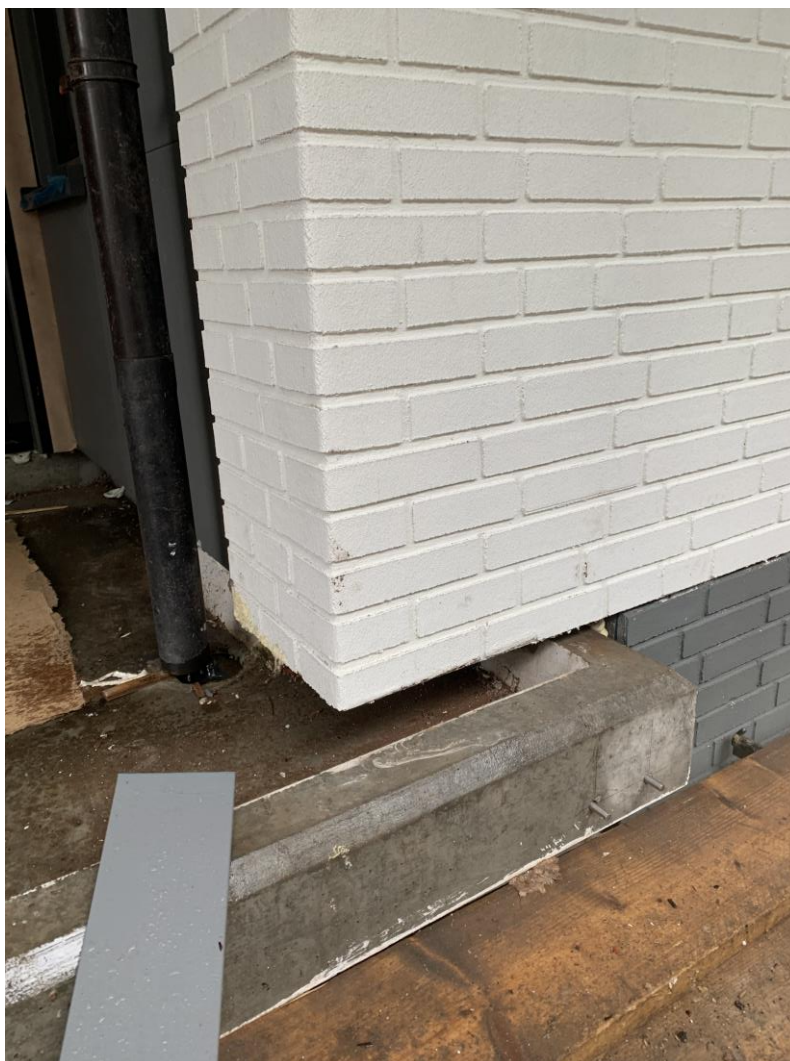
Figure 76 Detail of the connection of the prefab façade element with the existing balcony floor slab. It shows the complications of the existing structure and the precision in the design, manufacturing and mounting process, which went well without failures.

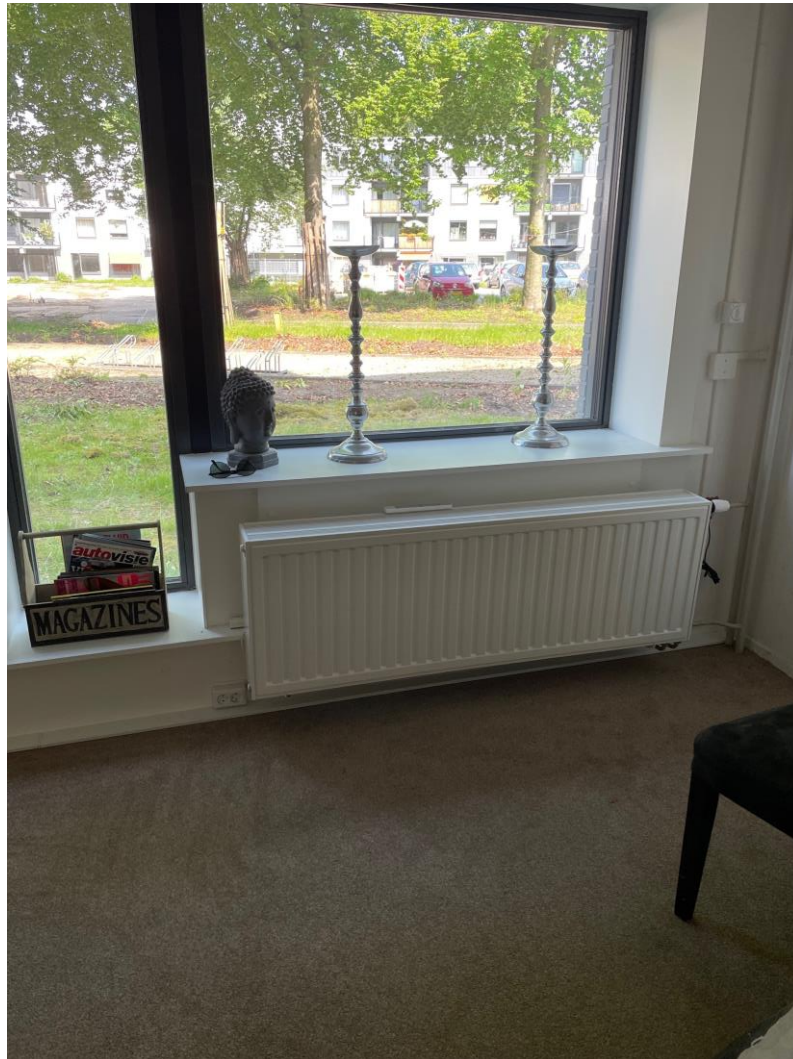
Figure 77 ClimaRad installed behind the radiator and throughout the new envelope

The ClimaRad 2.0 is a highly innovative ventilation unit with a built-in heat exchanger and sensors for CO₂, humidity and indoor and outdoor temperatures. The ventilation unit (WTW) is 'hidden' behind a tiltable radiator. This hardly takes up space. The ClimaRad 2.0 provides ventilation and heating per room and is placed against an exterior wall. Supply and discharge of air thus takes place directly through the facade, whereby the supplied air is preheated. The maximum air volume is 125 m³/h at a low fan power demand of 0.12 W/m³/h

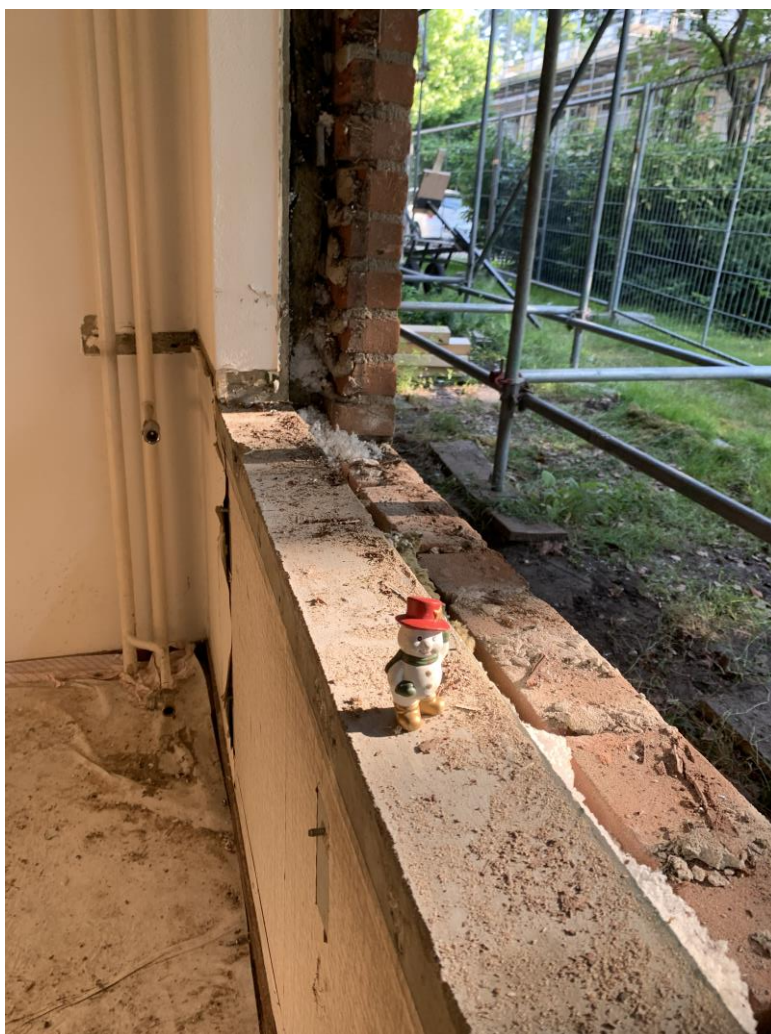
Figure 79 The existing radiator has been dismantled to be replaced with the Climarad decentralized heat recovery radiator.

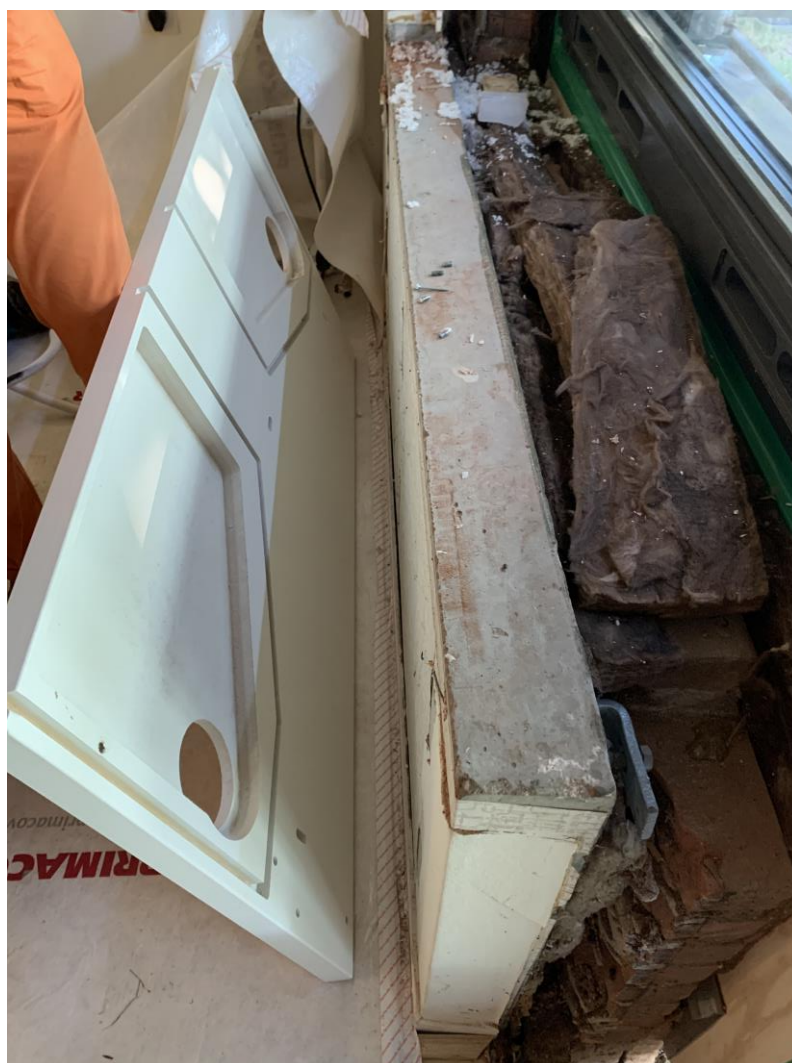
Figure 80 Specific timber device which guides fresh air from the façade into the decentralized ventilation unit.

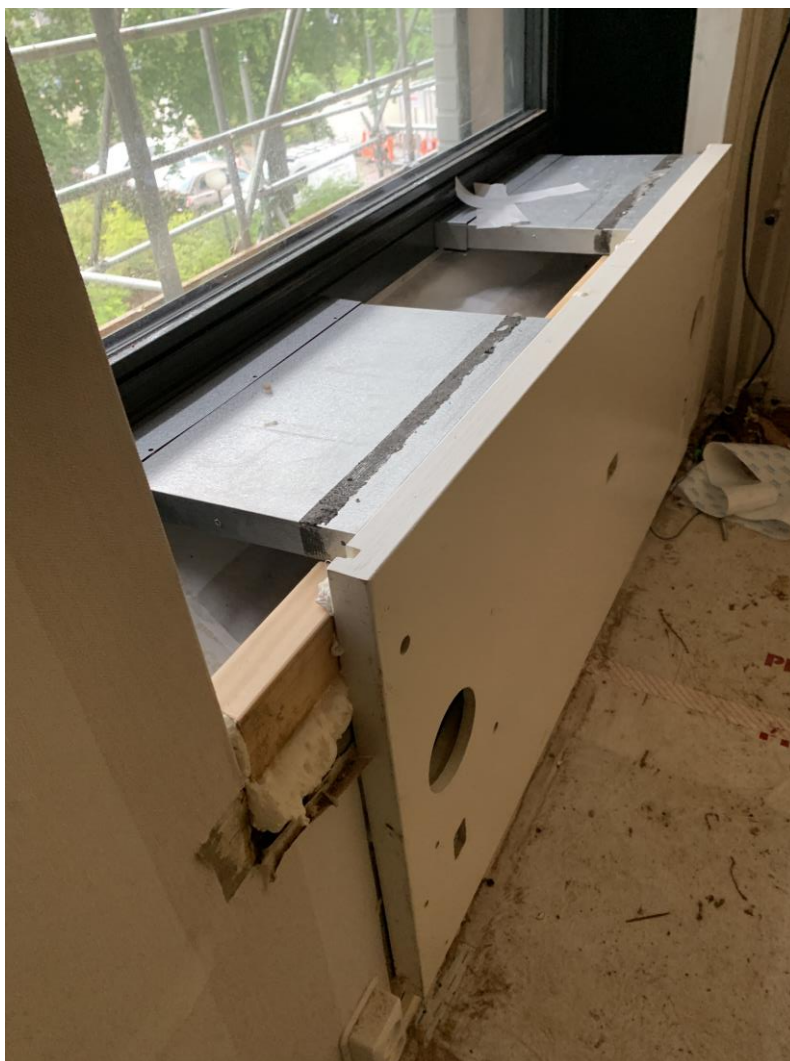
Figure 81 Ducts connecting the façade to the interior (supply and exhaust air)

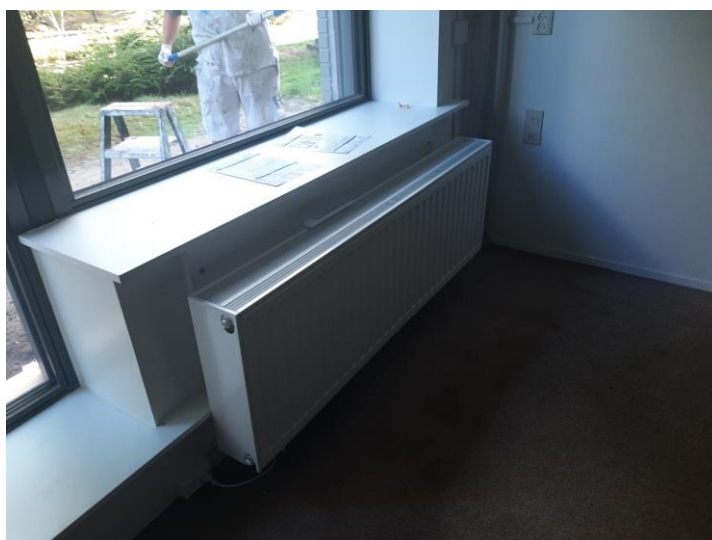
Figure 82 The completed decentralized ventilation radiator

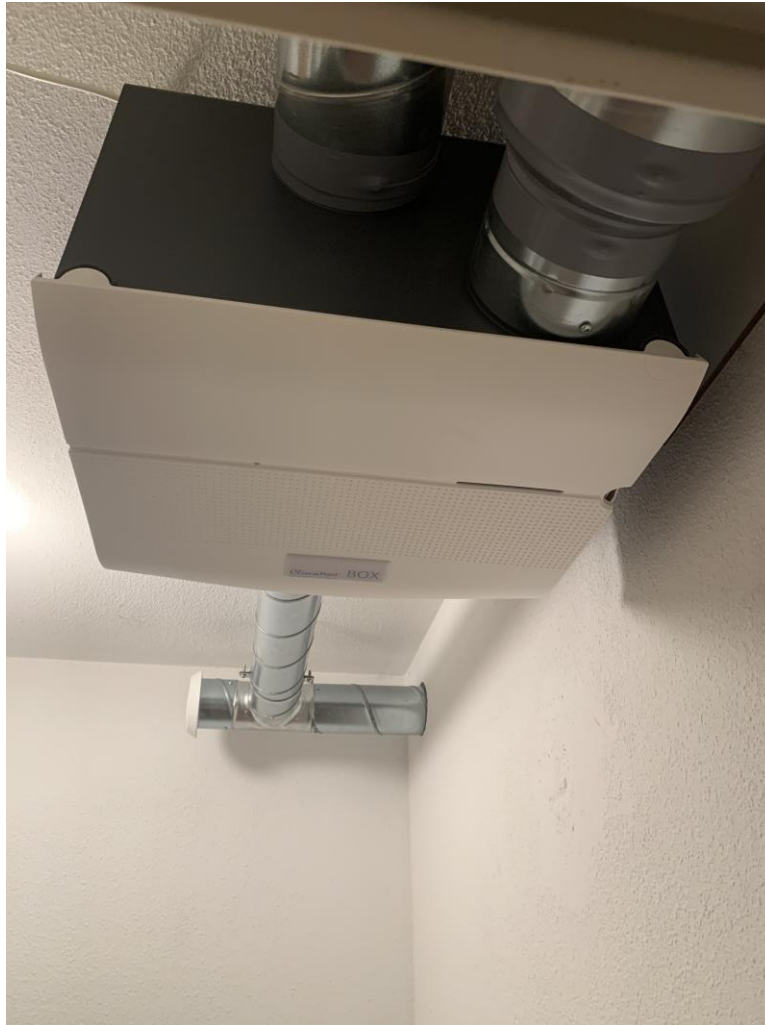
Figure 83 Climarad exhaust fan for bathroom, toilet and kitchen in the 4RinEU demo-apartments.

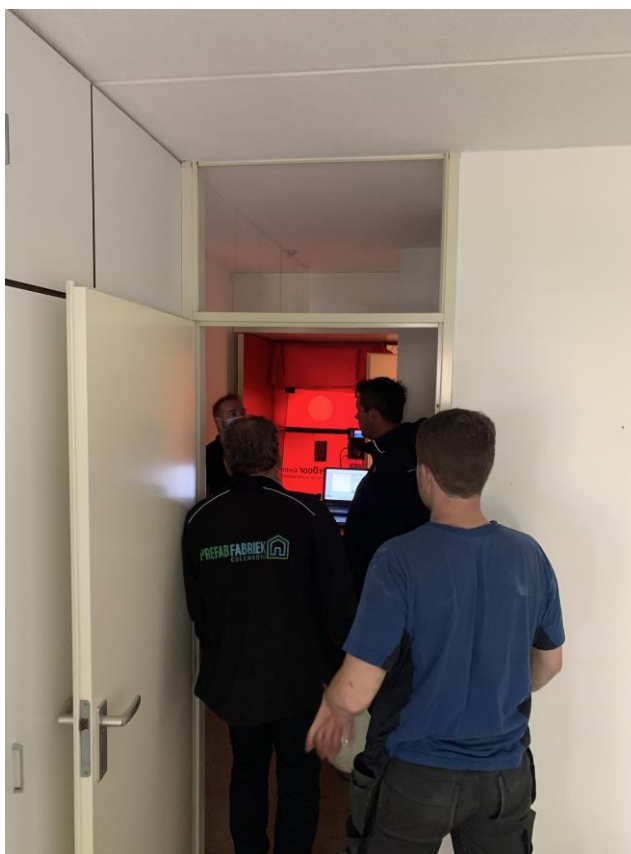
The result was almost as good as aimed for. The n50 value was 1.7 ach whereas the objective was 1.5 ach, as presumption in the energy simulations for the 4RinEU demo project. Specific leaks between the prefabricated window element and the floors were identified. Since the flooring material of apartments remained in place it is hard to improve this specific small gap afterwards. In one apartment these corrective measures were taken. In this case a new blower-door test resulted in the required n50 value of 1.5 for the whole apartment.

Figure 85 Blower-door test in an unoccupied apartment in Marienheувel, Soest

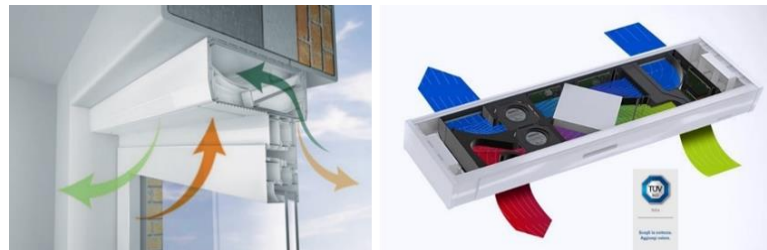
The PMF openings, include in the top part of the balcony, mechanical ventilation units with air filter and heat recovering (74%). The model selected is *Thesan Air Care ES* (air-flow 15 m³/h- 41 m³/h) (<https://www.thesan.com/>)

Figure 89. Mechanical Ventilation unit of the PMF facade

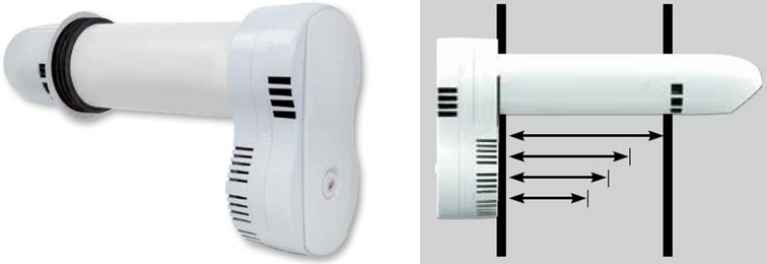
To complete the ventilation system in the apartments of the PMF, it was necessary to have mechanical ventilation units with heat recovering (75%) in the rooms of west façade. The units were placed in the inside of the existing façade and a duct (10cm diameter) makes the interchange with outside. The selected machine is *Ecoroom de S&P* (airflow 25 - 45m³/h). In addition, the airtightness of the perimeter of the existing openings -windows, balconies, doors- was improved.

<p style="text-align: center;">Figure 90. Mechanical ventilation unit in West Facade</p> <p><u>Inside the apartments</u></p> <p>To complete the ventilation system an extractor fan had to be installed in the bathroom air-grill.</p> <p>In addition, to improve comfort in summer, it was initially foreseen to implement the <i>Smart ceiling fan</i>, in at least 3 apartments. However, the solution was discarded, mainly due to the Smart Fans dimensions. Its height - 40cm - was not compatible with the apartment free height - 2.40. It could happen that users could touch them, even by involuntary movements damaging the technology or even themselves.</p>
<p>RES</p> <p>Production</p>

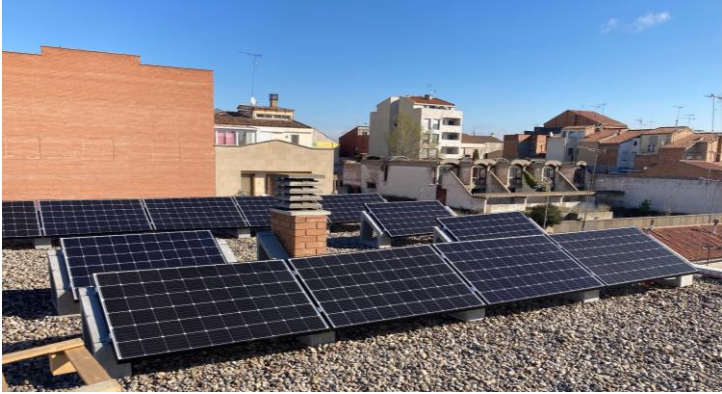
<p><u>Roof</u></p> <p>18 Panels are installed on the remaining free space of the roof. They are south oriented and with a 28° tilt. The Panels selected are polycrystalline, have a power of 250W and a surface of 1.65mx0.99m- this represents a global photovoltaic surface of 29.46m².</p>

<p>Figure 91. 18 Photovoltaic panels are placed on the roof</p> <p><u>East Façade (PMF)</u></p> <p>On the roof there was little space for PV panels due to the existing ST panels, for that reason it was interesting to use the East Façade too. The PMF allows using the 20 Photovoltaic panels as external cladding. The position of these panels – just in 2nd floor – was decided considering the cost-efficient Early Reno analysis and aesthetical criteria of the architecture project.</p> <p>The Panels selected are polycrystalline, have a peak power production of 236W and a surface of 1.5mx1.20m -this represents a global vertical surface of 36m².</p>

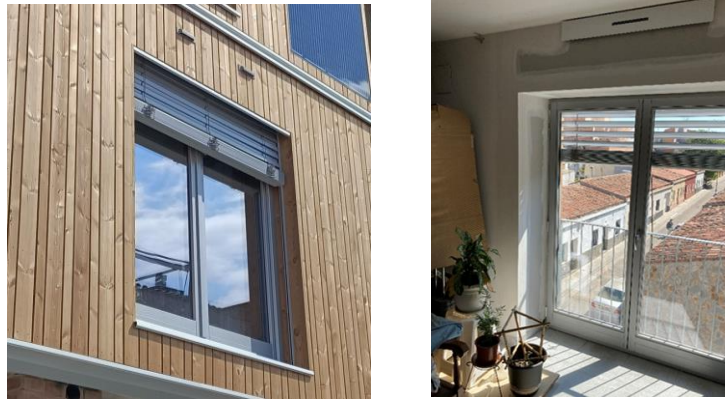
Figure 92. New aluminum folding shutter compatible with ventilation ducts

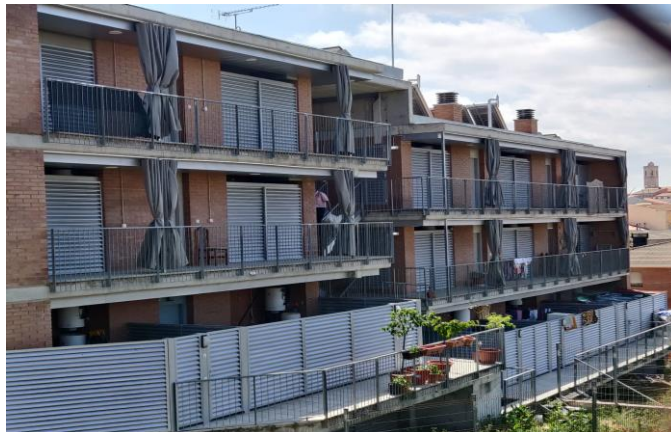
This façade is exposed to a high solar radiation during summer, and the metallic surfaces of the laundry area enclosures, increase the risk of overheating. Therefore, textile protections – vertical curtains- are installed in the corridor, to protect this common area from sun.

Figure 93. West facade with the sun protection curtains

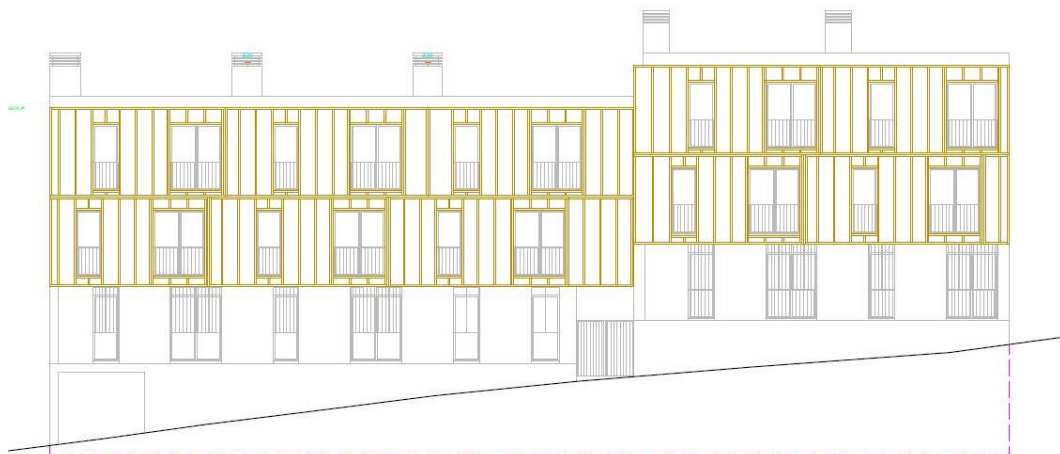
Concerning the timber structure of the panels, each element has a section of 60x140mm and is classified as C24 (timber resistance). The project initially defined a pine wood – although finally fir tree wood with a biotic treatment was used.

Figure 95. Structural composition of the PMF with the final 10 panels horizontal panels division

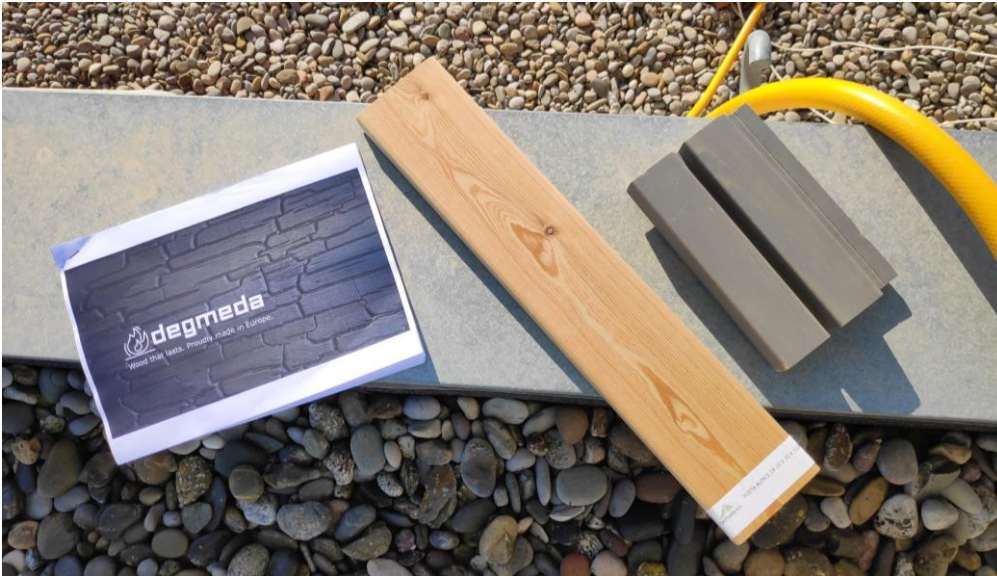
Figure 111 The different types of finishing considered for the timber external cladding (from left to right); *Yakisugi* treatment (burn timber surface as external protection), thermo-treated (heat treatment to improve timber stability), grey colored coating for protection.

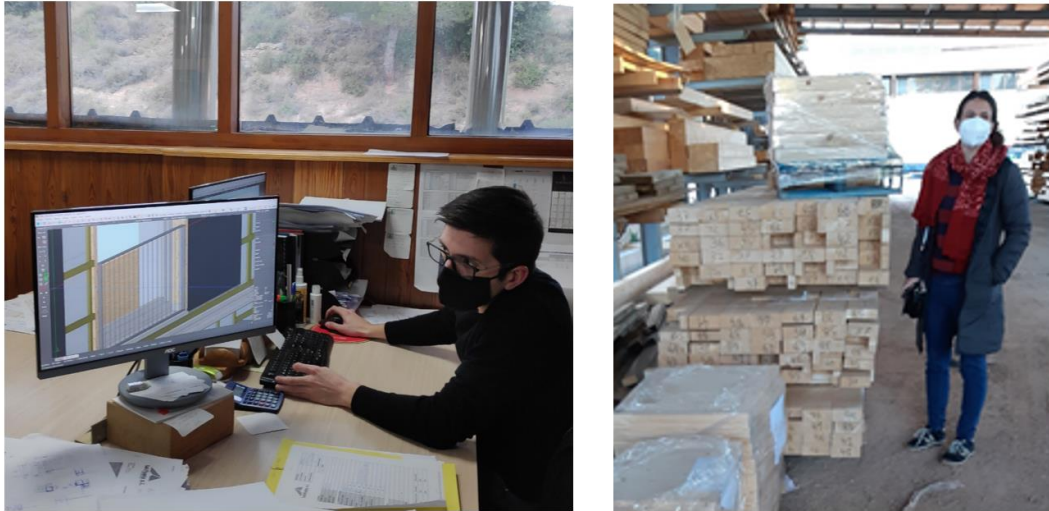
Finally, the detailed plans for the PMF were executed with a BIM model, in order to directly connect the information of the drawings – the dimensions of each piece – with the numerical control cutting machine, that automatically prepared the pieces.

Figure 112 Picture (left) The BIM model prepared by the timber manufacturer. Picture (right) the different timber elements cutted and waiting to be assembled.

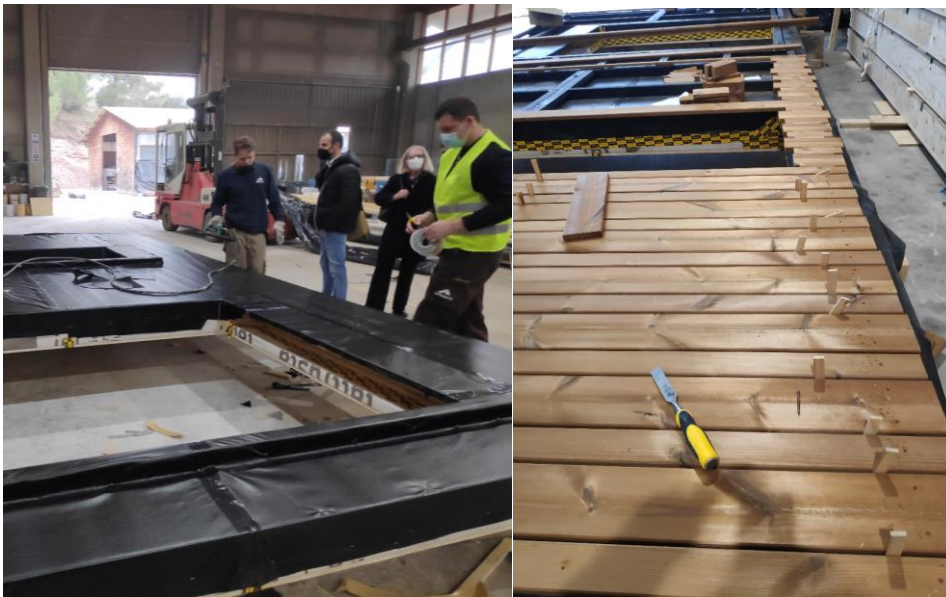
Finally, the panels were covered with a waterproof layer – made of polypropylene- and on them it was fixed the timber substructure that fixed the external cladding from thermo-treated wood, with expansion joints of minimum 0,5-1cm.

Figure 114 Picture (left) waterproof layer installation. Picture (right) Mounting external cladding

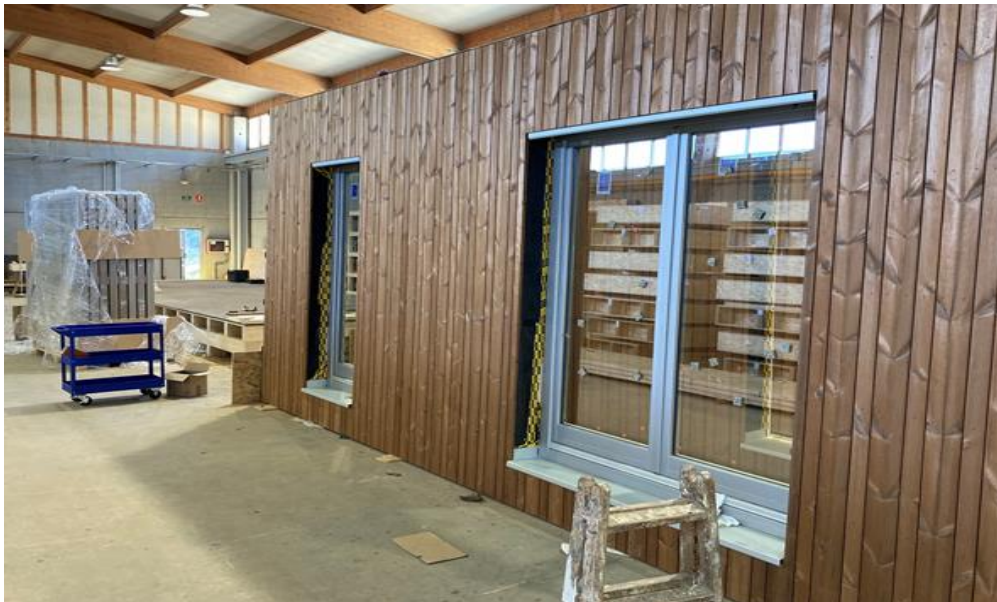
Figure 115 PMF façade panel from 1st floor almost finished and stored in the Workshop.

To sum up, the PMF façade panels were built in less than 15 days on the manufacturer workshop.

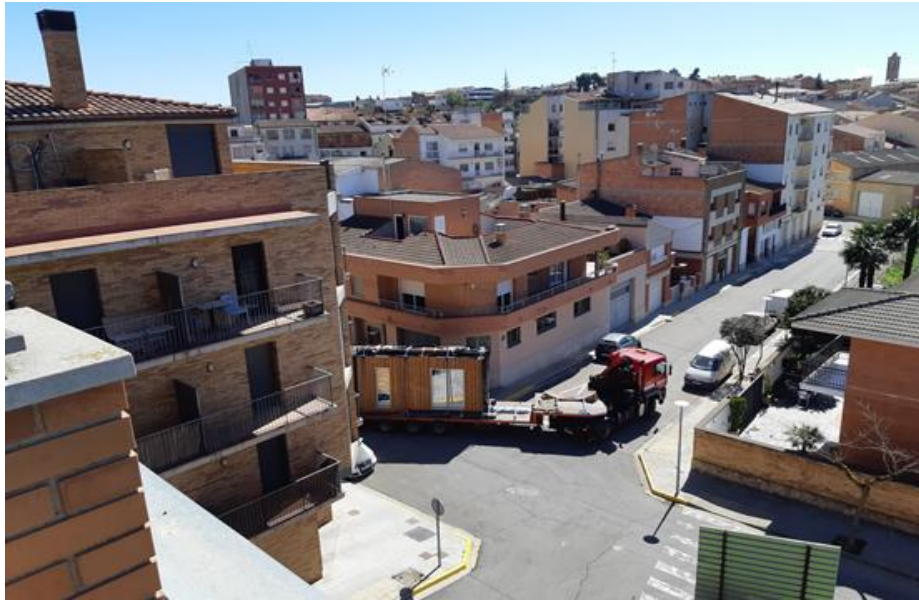
Figure 116 Arrival of the 1st PMF Façade panels to Bellpuig (date:18.03.2021)

No problems appear during the transportation, and there were no access problems to the demo-site either, as “Coma del Forn” Building is well located close to a main street. Even though, due to the slope of the street -close to 10%- it was necessary to select a gooseneck truck. This type of truck with higher wheels on the front cabin, facilitated the procedure of elevating the panels with the crane, by creating a more horizontal position thanks to the difference of height between the cabin and the rest of the truck.

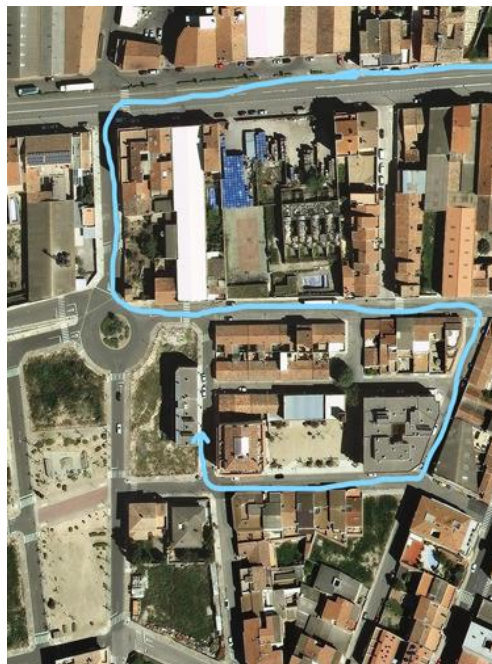
Figure 117 (left) Map with the circuit of the long truck. Picture (right) of the crane picking a PMF façade panel from the gooseneck truck.

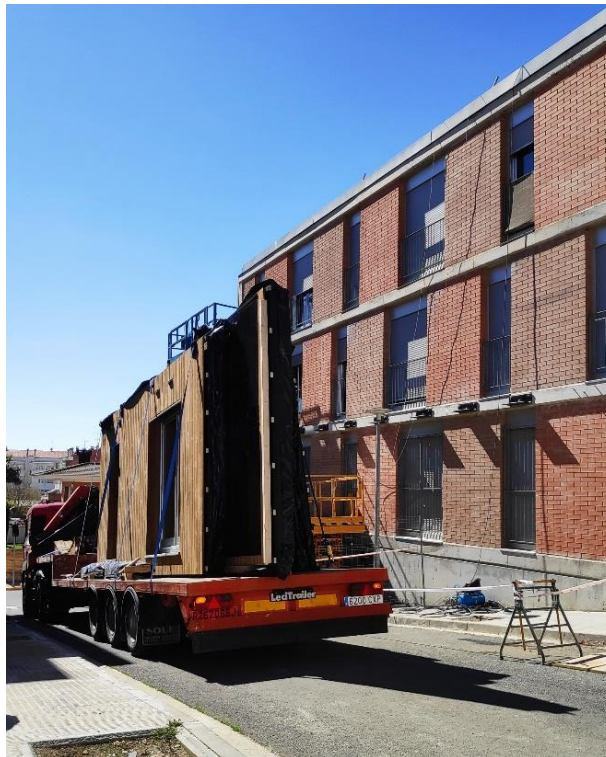
Figure 118 (left) The metal angular plates installed. (right) Installation of 1st PMF panel

The panels were anchored to the existing façade the same days of their arrival to the site. The first day of the installation - Thursday 18th of March 2021-, some previous preparing works were done. The installers started by fixing the bottom metal angular plates to the existing façade – in the slab area- and lately the panels of the 1st floor were anchored to them. Afterward, the existing aluminum sill of the balconies were removed, while the railings and the balconies remained on place - for security reason were removed after the installation of the PMF panels-.

Then the same day, at midday, the first 2 panels were installed between the 1st floor and 2nd floor, starting from the south-east corner. This two first panels from the corner had to be put carefully in order to guarantee their correct correspondence with the existing openings. Having them installed, the remaining 2 were much easier and quicker, as the guideline was already established. At the end of the day, 4 panels were already anchored.

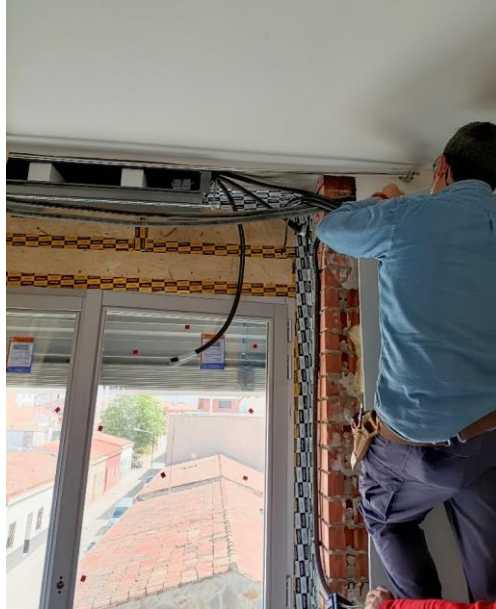
Figure 119 (left) PMF Façade panels anchored. (right) Inside finishing works

Then, with a second day of transport/installation – Monday 22nd of March 2021- it was enough to have the 10 panels anchored. Then the rest of the week, the procedure continued, from the outside, with some finishing tasks on the perimeter of the façade (sides, and upper parts of the panels).

Having the panels on their place, then the second step was to remove the existing balconies, replace the railings -and cut to adapt to PMF-, as well as install the ventilation units and the shutters. In addition, several inside finishing tasks were necessary - in walls, floor and even ceiling-. This part took about one month. This is more than what it was

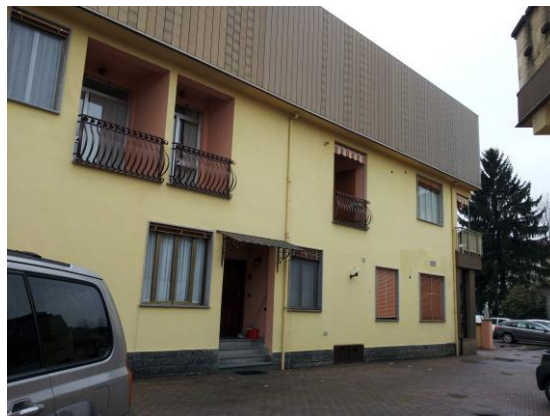
Figure 120 External view before 2020 interventions

Building has a reinforced concrete structure, with central lowered beams that run along its length, non-load bearing walls and a wooden pitched roof, masked on the outside by a bronze-colored paneling that give the effect of a flat roof. External walls were not insulated, with two layers of brick with an air gap between them.

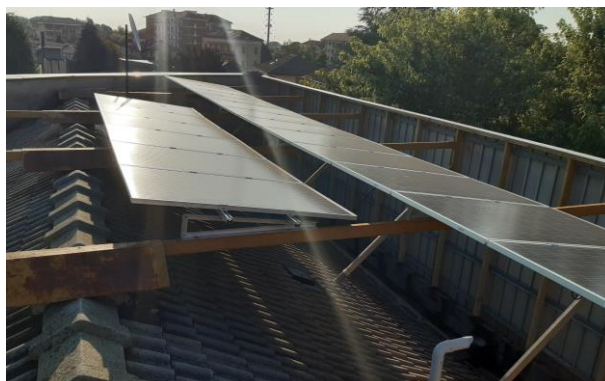
Figure 121 Photovoltaic System

A new photovoltaic system was installed in 2016, with 8 kW of peak, and a single Point of Delivery (POD) for electricity was installed for the whole building, where apartments, common parts and photovoltaic are connected: the measurement of individual consumption and photovoltaic production is read by special meters, connected to a remote reading system.

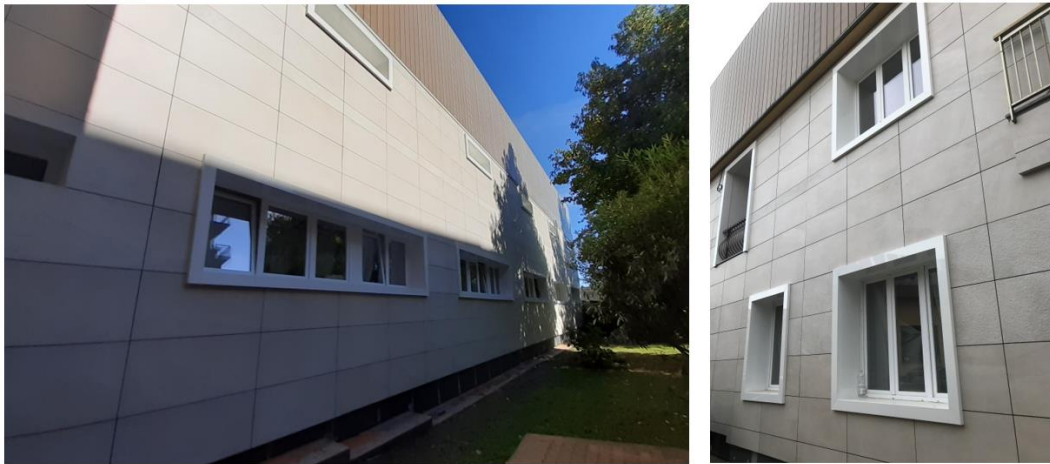
Figure 122 Details of the finished ventilated façade by Halfen

Tiles, in addition to finishing the facade of the building from an aesthetic point of view, also create the ventilated cavity, a fundamental feature of the vented wall, with an air gap between themselves and the layers of insulation.

With the façade installed within BuildHEAT project, Via Tabona building has started to have a proper insulation on external vertical walls, with a thermal transmittance of only $0.190 \text{ W/m}^2\text{K}$.

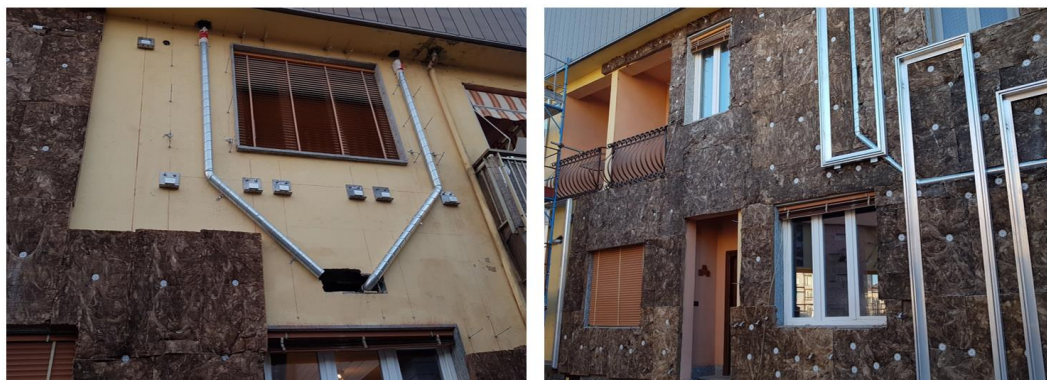
Figure 123 Installation of ventilated façade with ducts passage

Air ducts, electrical wires and cables and water pipes were placed behind the insulation layers of the façade, connecting the attic, the future HVAC station, to each dwelling: taking advantage of the new façade, the internal interventions in the apartments have been reduced to a minimum, avoiding drilling for the passages of the systems, moreover they remain protected from external weather, and isolated, from the façade itself.
