4RinEU

Reliable models for deep renovation

D5.3

Report on deep renovation packages as tailored and implemented in the demo cases

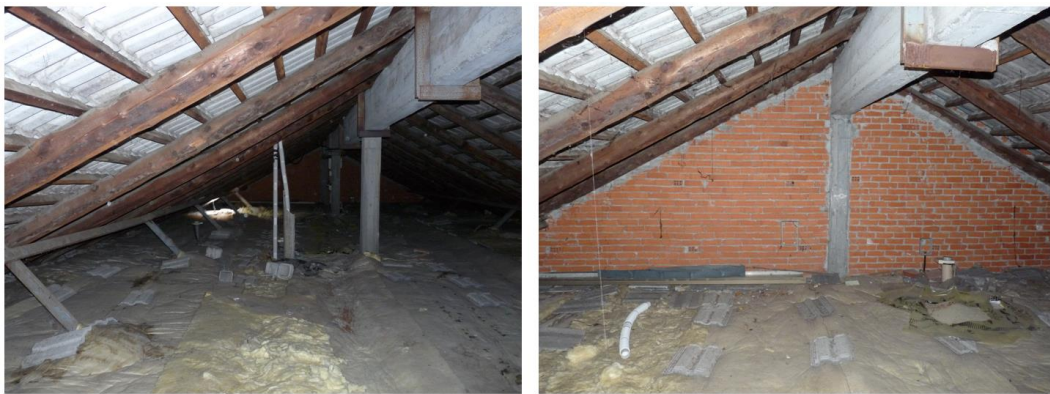
Figure 124 Attic situation before 2020 interventions, with the damaged mineral wool insulation

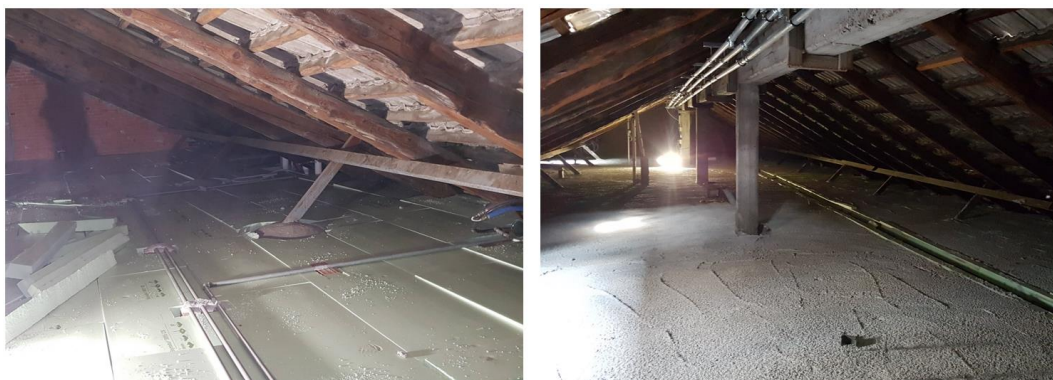
Figure 125 Attic during EPS coating (on the left) and the final result with light concrete slab (on right)

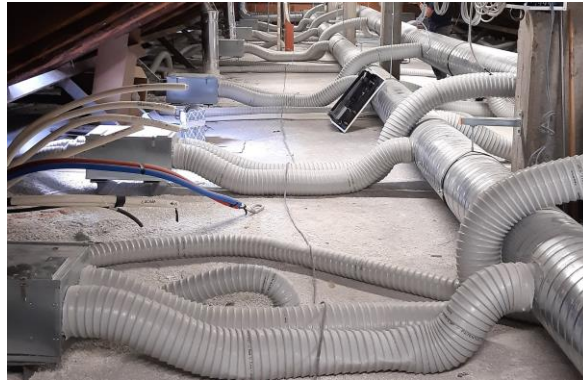
Figure 126 Ventilation ducts and recovery units during installation

The new centralized ventilation system consists in two fans, one to supply fresh air from outside, the other to extract exhaust air. Two main steel round ducts run in the attic, connecting the fans with the 13 static heat recovery units.

Each of these recovery units, with an efficiency around 85% supply the fresh air from the attic to the main room of the dwelling, while the exhaust air is always extracted from bathroom, then passes into the recovery unit and it is taken away.

Ducts connecting recovery units and ambient passes into the ventilated façade. In the dwellings, ventilation system consists of a wall grill, in the wall or embedded in a specially made plasterboard box, or ceiling mounted with Coanda effect deflectors.

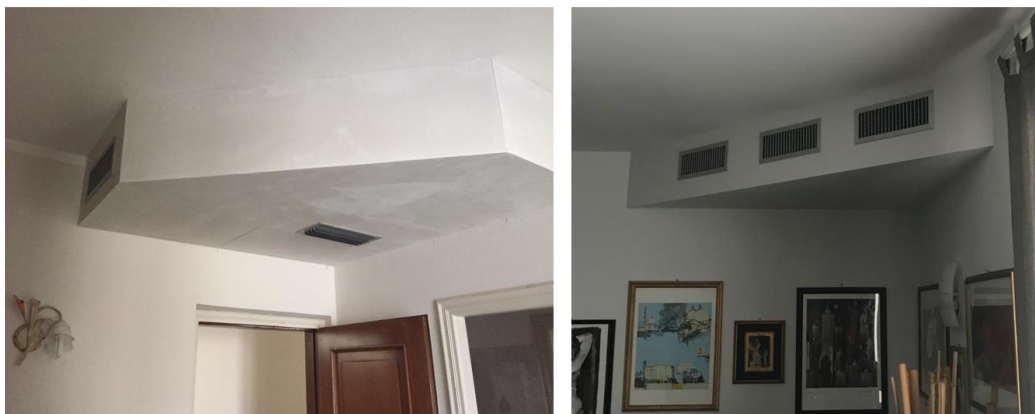
Figure 127 New fan coils hidden in the false ceiling

The choice fell on of fan coils because they can be electrically controlled by BMS system, they can act as heating and cooling terminals and they provide heating/cooling quickly in the ambient. They are placed in the already present false ceiling of dwellings, with a supply grill and a snorkel grill, or in drywall placement built for this purpose.

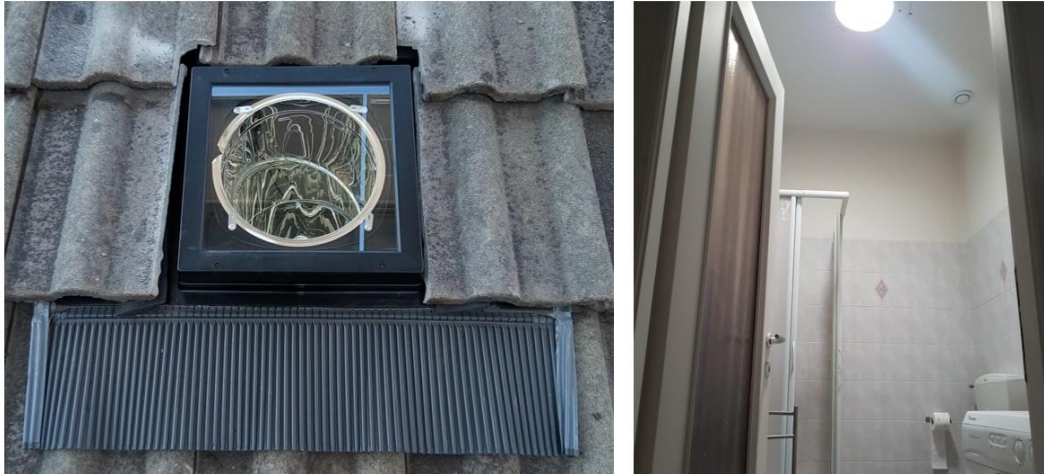
Figure 128 External intake and internal effect of light tunnels

In order to ensure natural lighting for the blind bathrooms on the first floor, "light tubes" have been installed that capture the sunlight from the roof and transport it, thanks to the large internal reflective piping, to the bathroom ceiling, where they look like a ceiling light.

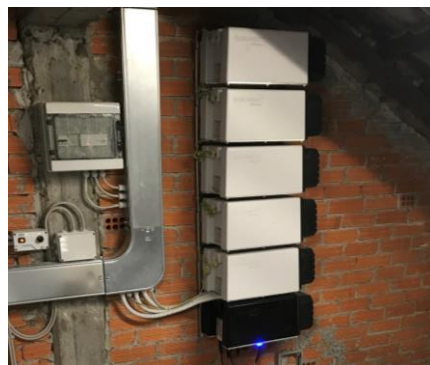
Figure 129 Electric Storage of PV system

The storage is located on the direct current side, between the panels and the inverter and has a capacity of 12 kWh, in order to make the most of the self-consumption of the energy produced on site.

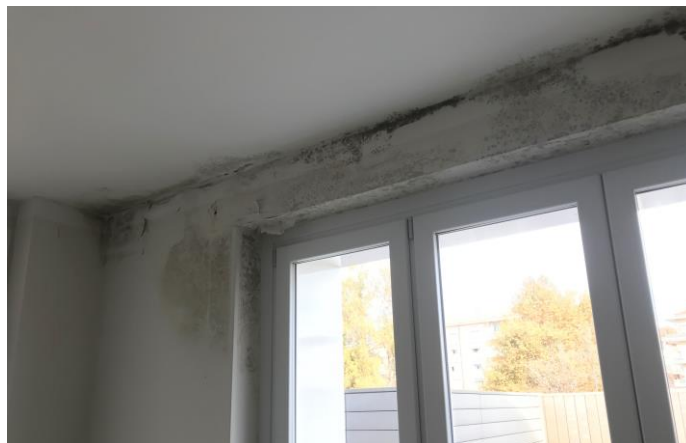
Figure 132 Presence of mold in dwelling 1 on the 1st floor

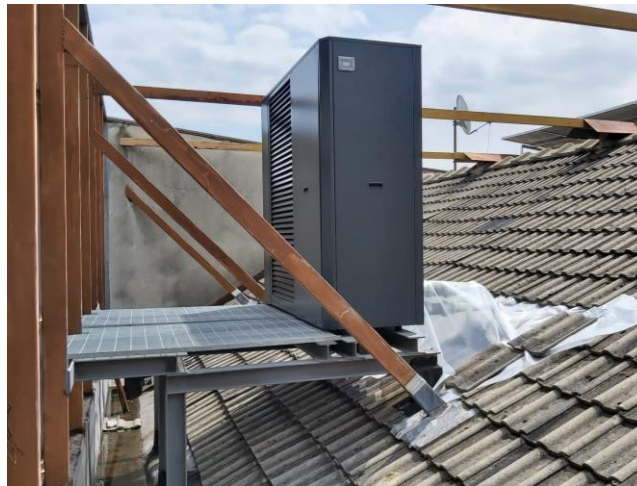
Figure 133 Heat Pump in Pinerolo during installation

In Pinerolo Demo Site, heat pump has been installed outside, on the roof.

A new basement has been created, made by H-beams and a grill, to support properly the machine, distributing its weight on a wider portion of the roof, and to allow an easier access for maintenance.

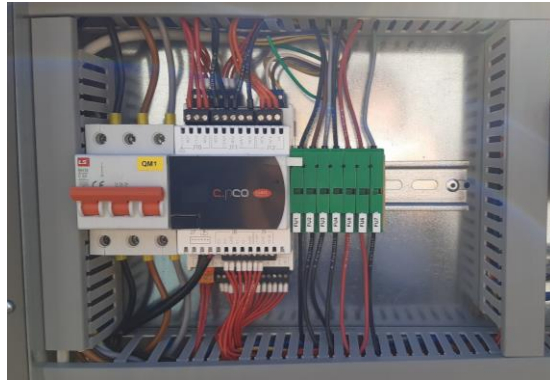
Figure 134 Heat Pump on board PLC

The heat pump works in perfect interface with the new BMS system of the building, with which it communicates through physical signals (dry contacts) and through the Modbus RTU protocol on an RS485 serial cable.

Operation is managed through a daily and weekly schedule, to control its switching on and off at certain times of the day. The temperature set point of the machine, which refers to the temperature of the water returning from the system, is defined continuously based on the external air temperature detected, in order to adapt its operation according to the real needs of the building. All the alarms from the machine are also collected and managed through the BMS system, which can send them to Tecnozenith, company in charge for the control of the system, in order to be able to intervene promptly in the event of a block or breakdown.

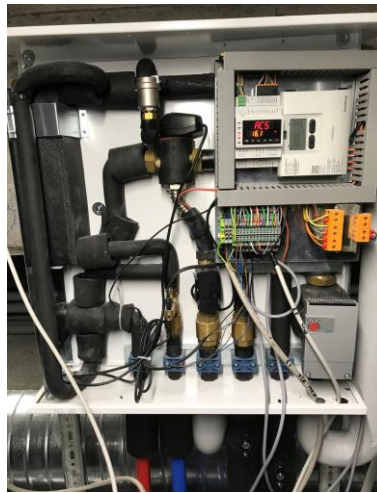
Figure 135 Inside the NRGate Box™ during installation

NRGate Box™ is a compact module, 623x185x627 mm in size, to be mounted on the wall, with a white painted sheet metal casing, which hides the internal components and allows only the hydraulic and electrical connections to be seen from the outside.

Inside, the water supplied by the heat pump passes through an electronic inverter circulator, which leads it to a first three-way valve: this valve diverts the flow of water towards the heating and cooling circuit, if there is a call from the thermostat contact, or towards the DHW production circuit, if the need for a flow switch is detected in winter. In this case, the production of domestic hot water is always given priority over the heating system.

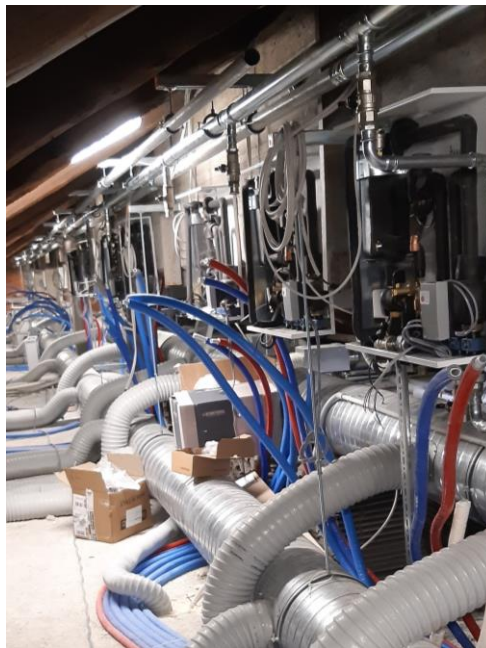
Figure 136 NRGate Box™ settled and to be connected during installation

Once the 13 NRGate Box™ arrived at the Pinerolo construction site, they were brought to the attic and fixed to the lowered beam that runs centrally to support the ridge of the roof.

Here they have been connected to the new pipes that connect them to the heat pump, always fixed to the beam, in an upper position, and to the sanitary pipes and fan coils arriving from the apartments, laid during the building insulation works during the BuildHEAT project works.

In the connections, manual valves have been installed on pipes at the exit of the modules, in order to make easier maintenance and interception in case of works.

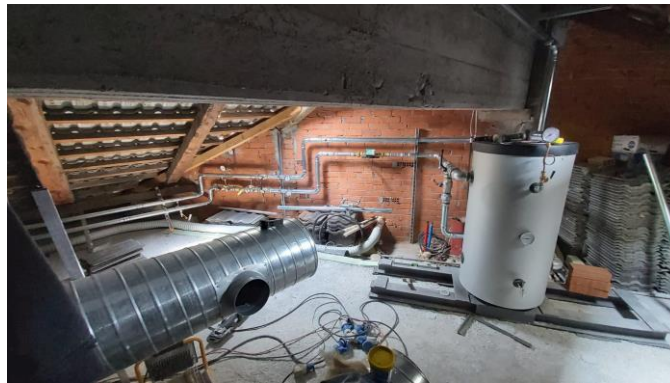
Figure 139 Hydraulic system during installation

On the return duct to the heat pump, 200-liters insulated inertial puffer has been installed, in order to make the system less subject to temperature changes when the heat pump is stopped due to defrosting.

On the puffer there is the safety valve, to guarantee expulsion of the water in case of too high pressure inside the system, to avoid dangerous situations or damage to the system itself. The safety valve is conveyed to a drainpipe. The expansion vessel is connected to the intermediate storage tank. From 80 liters, it guarantees elasticity to the water system, avoiding the creation of a rigid system with problems of water circulation and safety.

On the return pipe to the heat pump there are still a “Y” filter, to protect the heat exchanger inside the heat pump, as well as an ultrasound flow meter, connected to a heat meter. In this way, it is possible to know the instantaneous power and the energy delivered directly by the heat pump to the system, in addition to that recorded and used by the various accommodations.

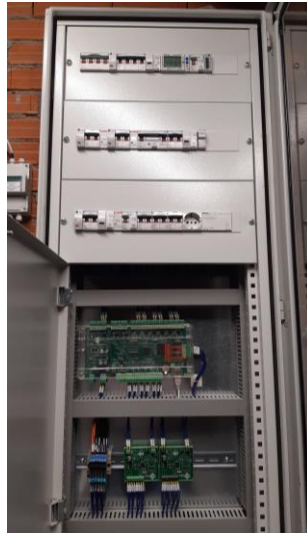
Figure 141 The main switchboard

This main electrical panel of the system supplies, in addition to the heat pump, the lighting and electrical sockets of the attic, the fans of the ventilation system, the controller of the BMS system installed inside it and the communication system to the outside of the BMS itself.

All electrical connections needed to power the new devices have been made, including heat pump, fans and heating cables. These latter are cables positioned around the pipes placed outside, connected to the heat pump, below the layer of insulation: if activated, they heat the pipe and consequently, the water inside, to avoid freezing in conditions rigid. This installation was necessary because the water circulating in the system is not glycoled.

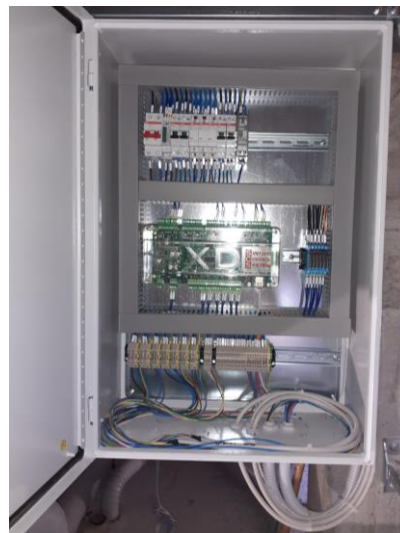
Figure 142 HVAC Electrical panel of a dwelling

To feed and act on the systems of each housing, 13 electrical panels were installed. These are powered by the electrical panels of the corresponding housing and power their NRGate Box, the boiler and the new fan coils, as well as the BMS controller for managing the individual dwelling. There is also a meter to measure the electric consumption of the HVAC-DHW systems of each dwelling.

This configuration makes the control of the system of each apartment independent: an electrical problem on one of them does not compromise the functioning of the remaining apartments.
