## D7.4b - Renovated Case Studies, Madrid

**Deliverable Title:** D7.4b – Renovated Case Studies, Madrid

The building selected by EMVS as a demonstration of project iNSPiRe practices is located at 47, Canción del Olvido street, Ciudad De Los Angeles in Madrid.

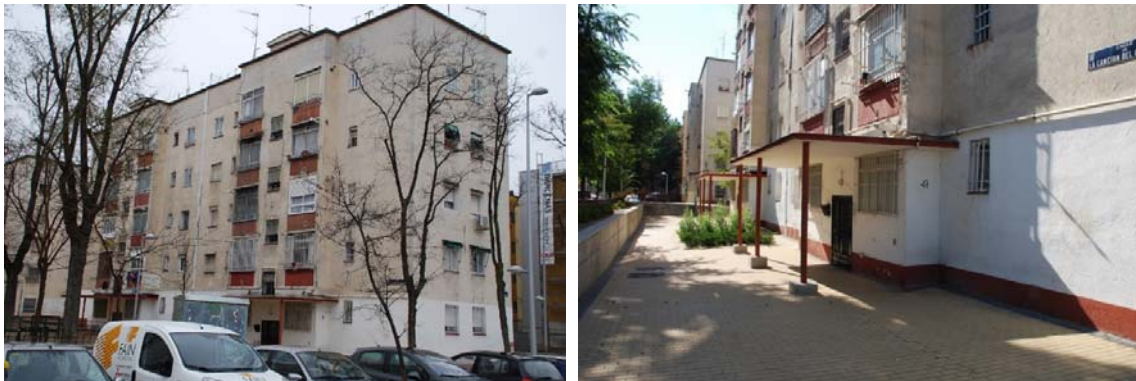
Figure 1 - North façade

The condition of this property prior to the renovation jobs showed a number of defects, in particular foundation problems derived from the structure's differential settlement, which caused significant cracks on the building facade. Besides, the building envelope lacked any kind of insulation and the roof's insulation and waterproofing consisted of what is known as '*Catalonian roofing*', traditional Spanish construction technique consisting of an aired/ventilated chamber providing both insulation and waterproofing.

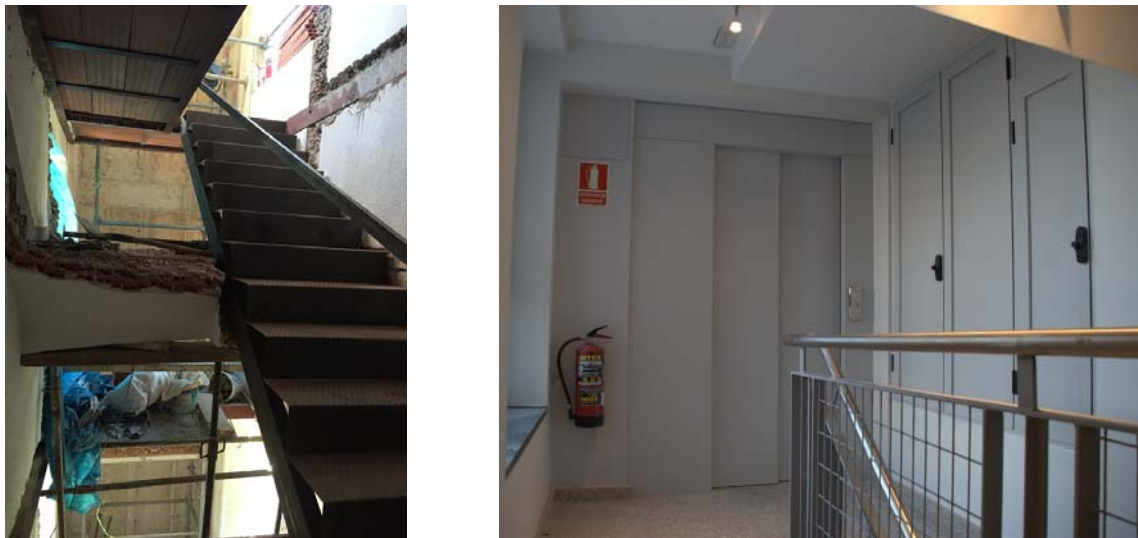
Figure 22 – Newly setup staircase during and after installation completion

5. In order to build the new lift shaft, the existing stairwell had to be demolished and a new one put in place. It is worth to keep in mind that during all this process the building was inhabited by owner-occupiers.
6. Construction of a new roof structure by means of a metallic ring structure braced with steel stringers and connected to the new lift shaft structure. The former has been finally replaced by a permanent concrete slab attached to structural walls.
7. Repair facade cracks, eliminate external artefacts (aerials, satellite dishes, etc...) and consolidate boiler exhausts and vents in order to increase the aesthetical value of the property.

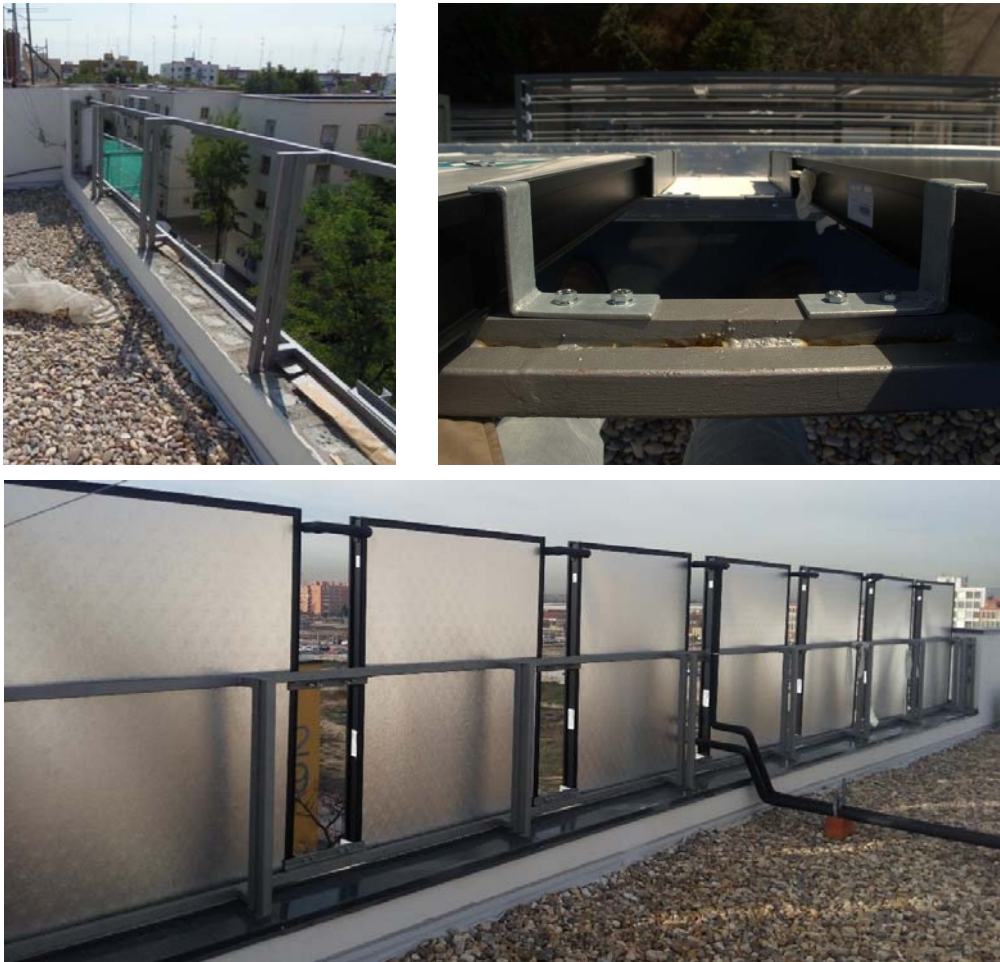
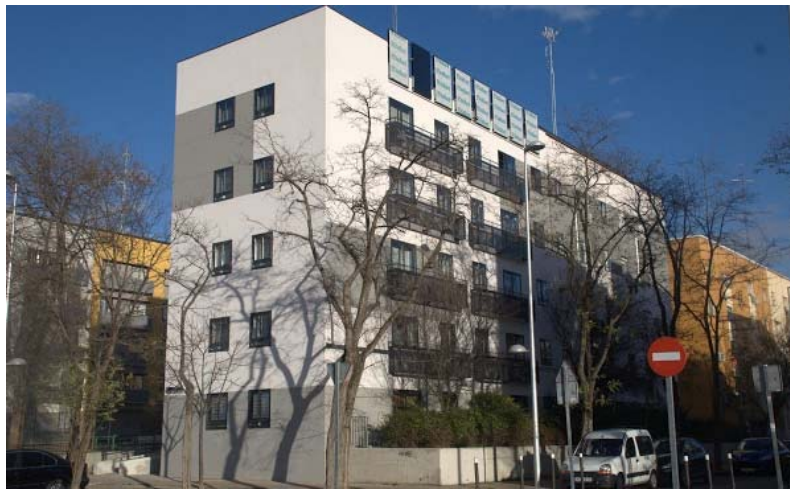
Figure 29 – Solar field installation on the south facing parapet

Figure 30 – South-facing façade with solar collectors installed

A 24 m<sup>2</sup> solar thermal plant feeds in fact the large thermal storage through an internal heat exchanger. Due to space and aesthetic constraints (the collectors are aligned with to windows on the same façade), 8 solar collectors are installed in parallel on the south facing parapet of the building, while other 2 collectors were installed on the wall of the technical room.

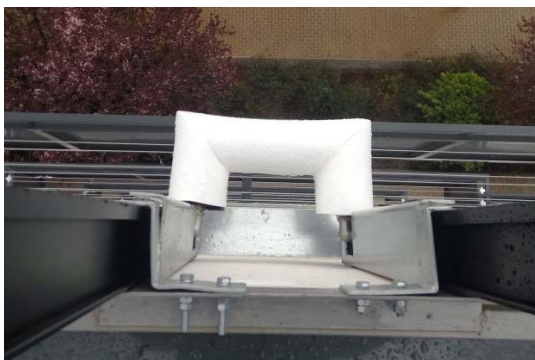
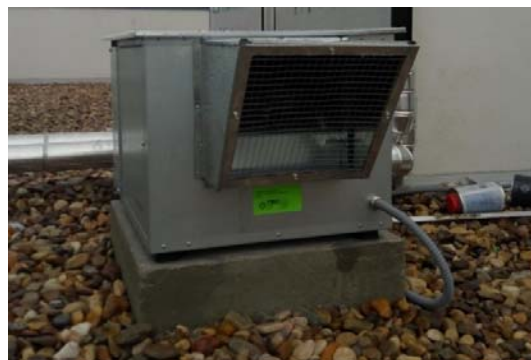
Figure 31 – paint protection on hardly accessible pipes (left) and heat dissipation unit (right)

Solar field pipelines are made out of copper and covered with 2 inches elastomer insulation. An aluminium layer protects insulation from degradation due to UV rays. Pipes with not easy access were covered with a special paint.

The solar field is designed and controlled as to avoid stagnation also during summer. However, eventual stagnation due to unforeseeable conditions is prevented thanks to a dissipation unit in parallel to the solar circuit, which is set on when temperature higher than 95°C are detected.

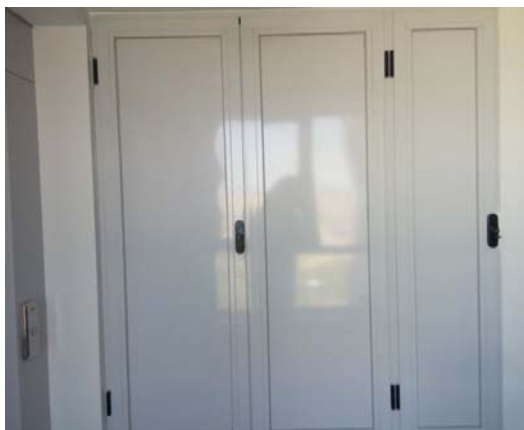
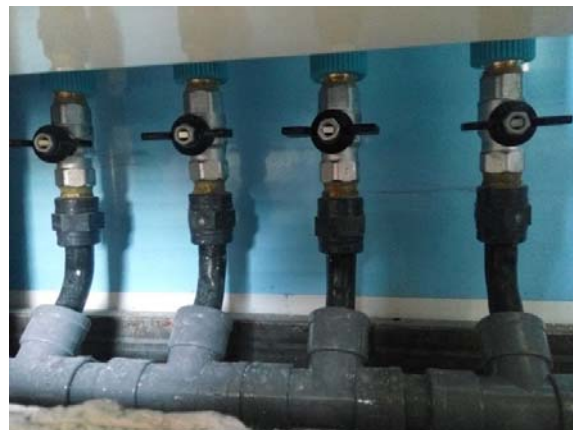
Figure 38 Safety door on the hallway and emptying system of the verticals lines

A security door was added, to protect the Energy Hubs and to separate the pipes shaft from the lift hall, in compliance with fire safety regulations.

At the bottom part of the shaft, an emptying system has been foreseen for the evacuation of water of the whole system.
